**Appendix C
Hazardous Materials Figures and Data
Polaris Building Annex – Fairbanks, Alaska**

NORTECH has compiled the existing hazardous materials data for the Polaris Building Annex for use as part of the demolition planning of this structure. This information is expected to be provided to prospective bidders as an appendix to Specification Section 801 that describes the requirements for abatement and/or demolition of these materials.

Location Map
 Polaris Hazardous Materials Investigation
 Fairbanks, Alaska

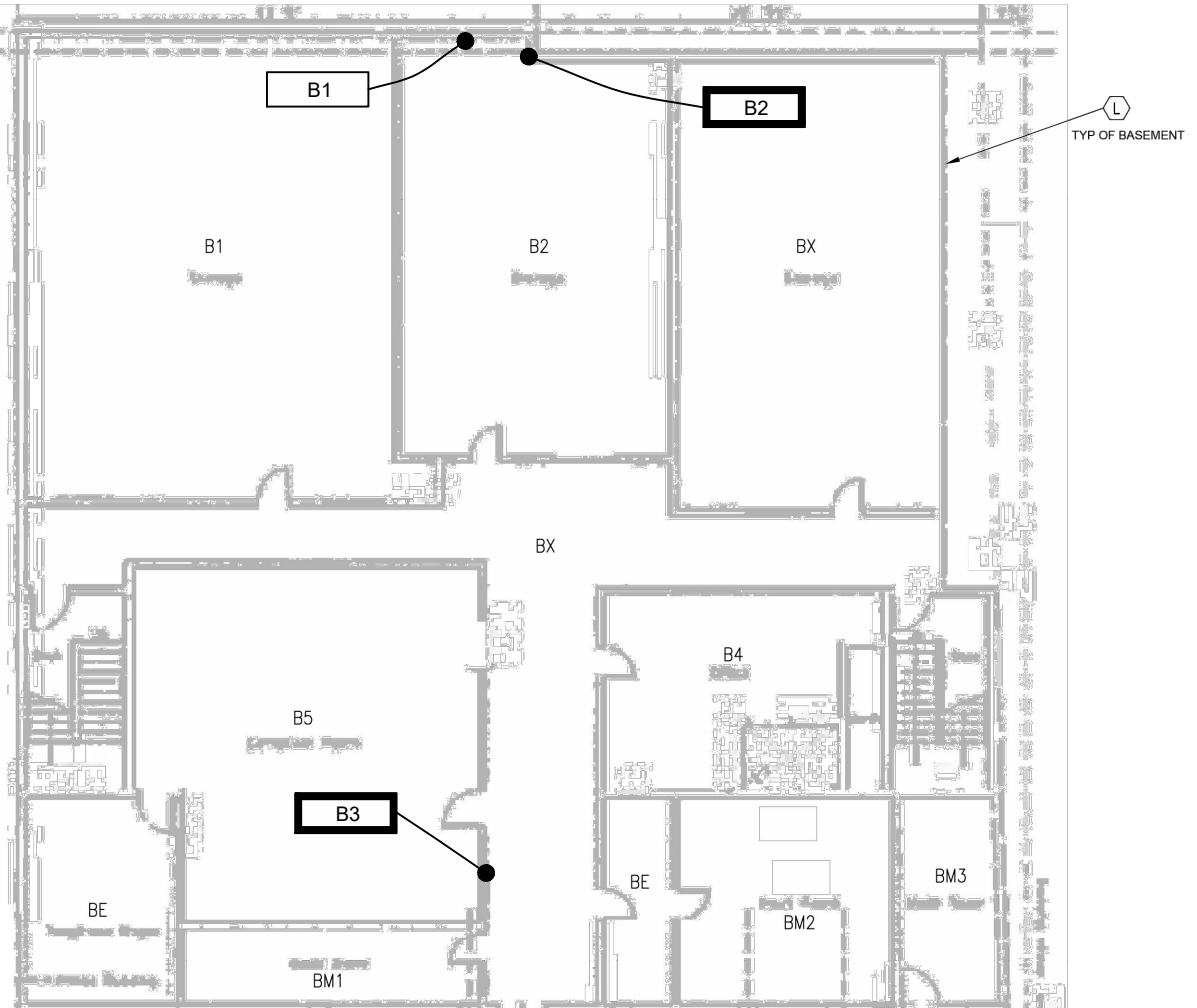
SCALE: NTS	FIGURE: 3
DESIGN: PLB	
DRAWN: SPH	
PROJECT NO: 20-2682	
DWG: 202682(annex)	
DATE: 02/15/2023

PCB Sample Results			
PCB Bulk by 3546/8082A (mg/Kg)			
Sample ID	B1	B2	B3
Color	unpainted	white	pink over white
Aroclor-1016	ND	ND	ND
Aroclor-1221	ND	ND	ND
Aroclor-1232	ND	ND	ND
Aroclor-1242	ND	ND	0.35
Aroclor-1248	ND	ND	ND
Aroclor-1254	ND	0.69	ND
Aroclor-1260	ND	ND	ND
Aroclor-1262	ND	ND	ND
Aroclor-1268	ND	ND	ND

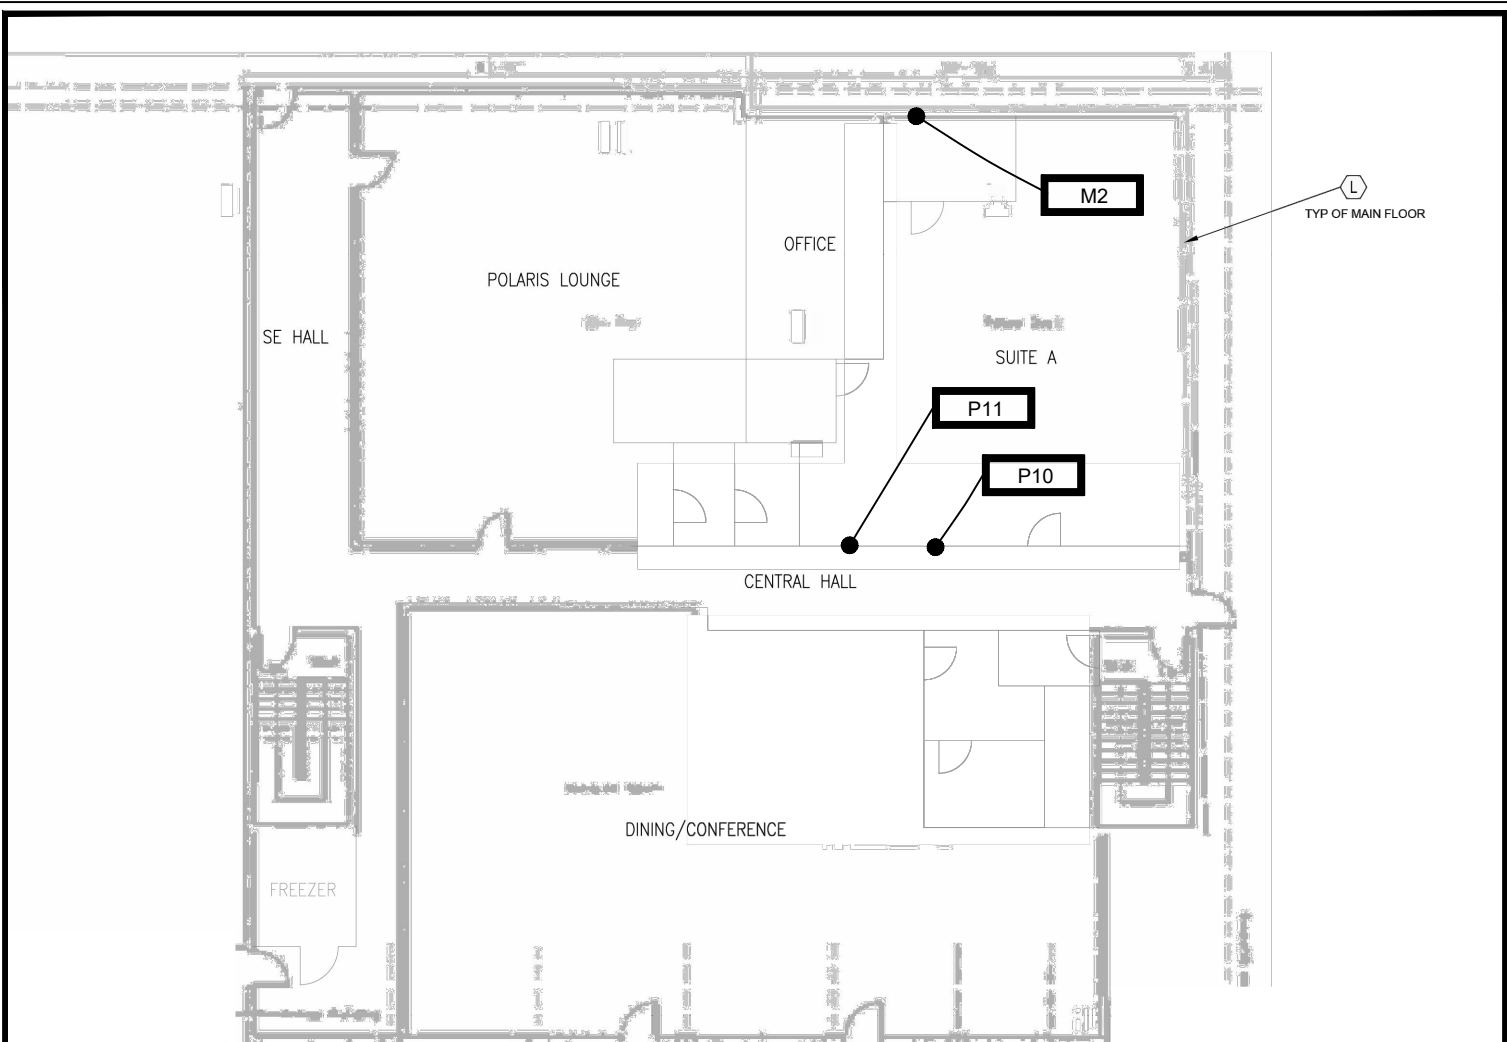
SCALE: NTS	FIGURE: 4
DESIGN: PLB	
DRAWN: SPH	
PROJECT NO: 20-2682	
DWG: 202682(annex)	
DATE: 02/15/2023

PCB Sample Results			
PCB Bulk by 3546/8082A (mg/Kg)			
Sample ID	P10	P11	M2
Color	off-white	teal	off-white
Aroclor-1016	ND	ND	ND
Aroclor-1221	ND	ND	ND
Aroclor-1232	ND	ND	ND
Aroclor-1242	7.2	6.6	1.2
Aroclor-1248	ND	ND	ND
Aroclor-1254	2.2	2.2	ND
Aroclor-1260	ND	ND	ND
Aroclor-1262	ND	ND	ND
Aroclor-1268	ND	ND	ND

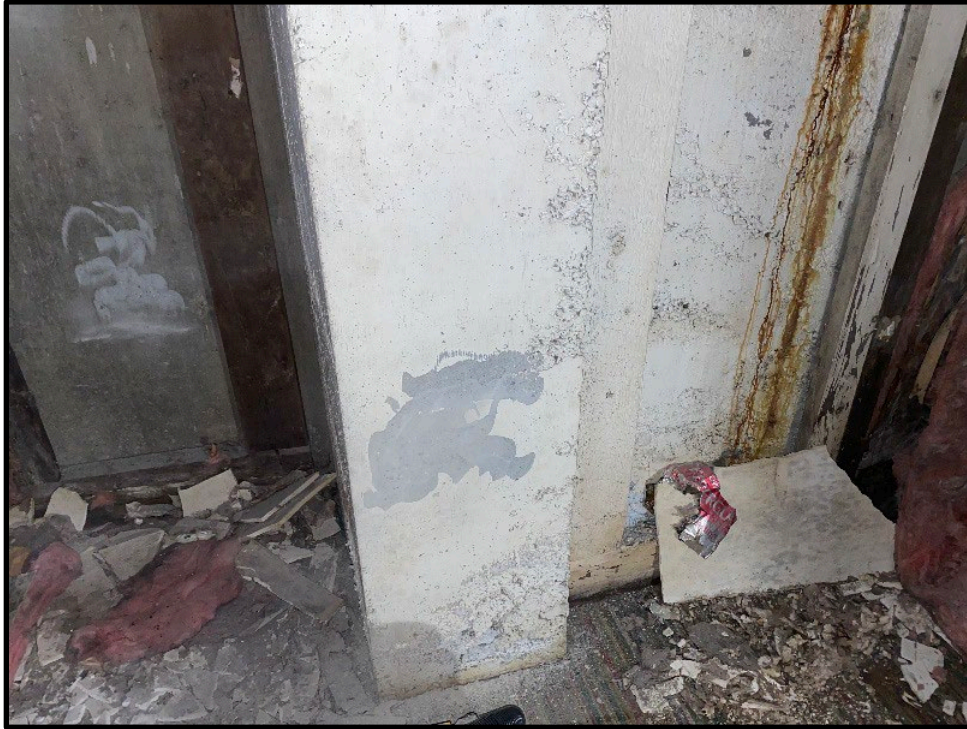
Photo 1: Basement – PCB Samples B1 & B2. Sample B1 collected from unpainted concrete in left of photo. Sample B2 collected from white painted concrete column in center.

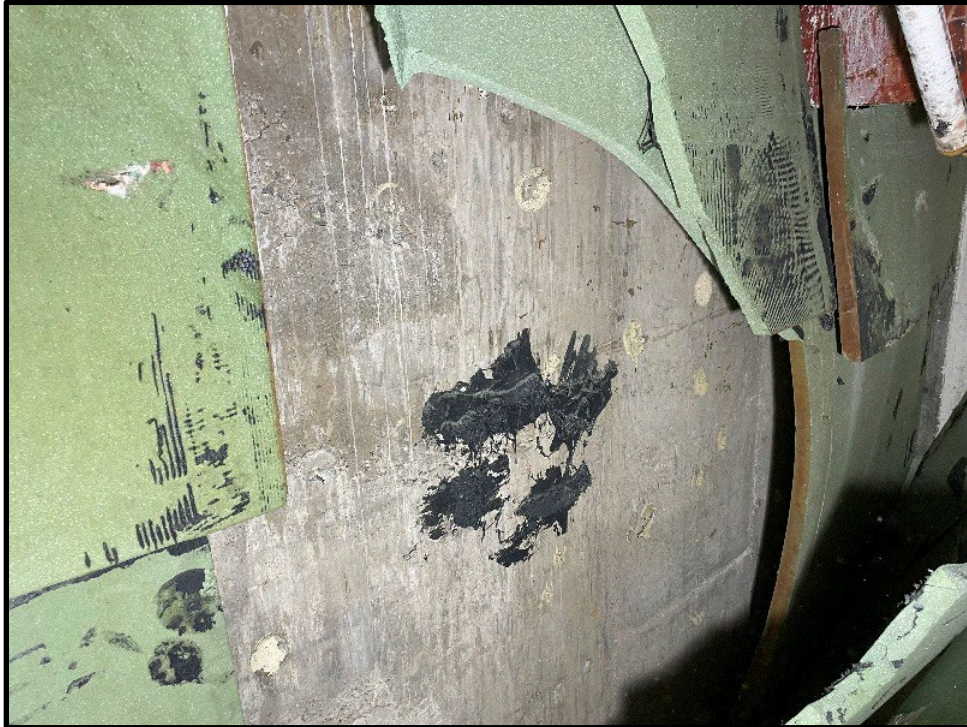
Photo 2: Basement – Stairwell exterior wall showing white and red painted stairs/supports in upper right of photo. Black mastic contains asbestos.

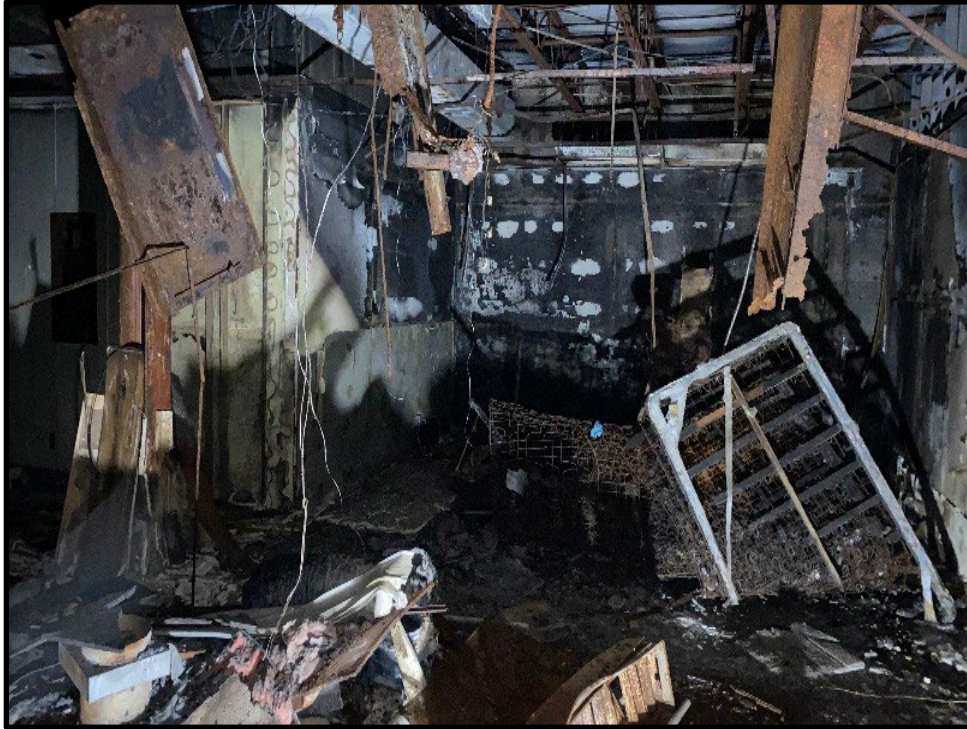
Photo 3: Main Floor – Dining/Conference room fire damage. Black in image is soot and burned materials.

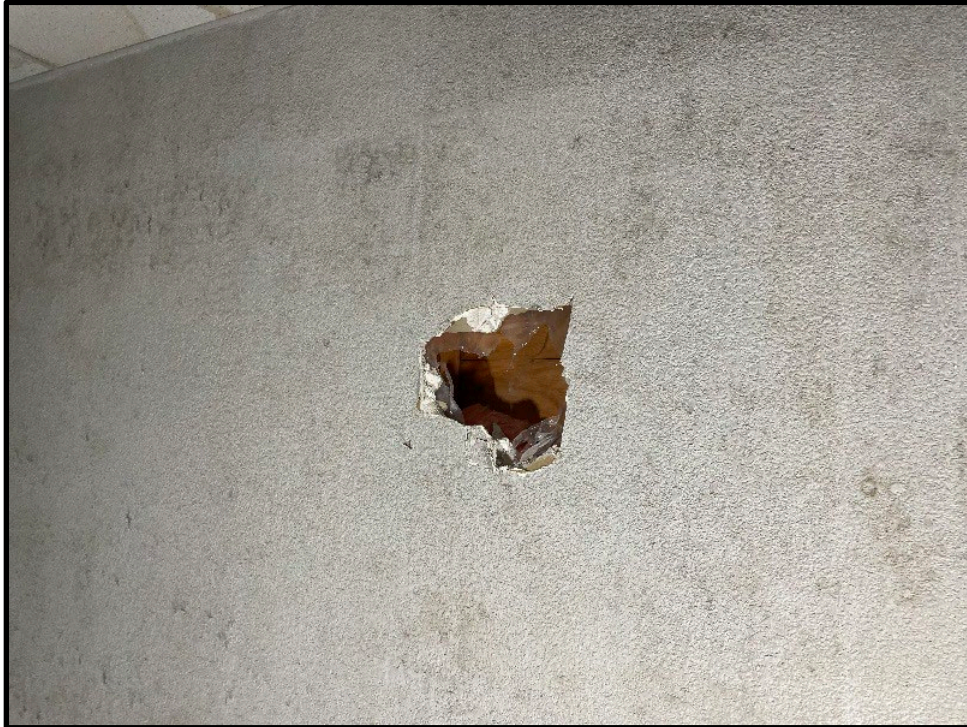
Photo 4: Main Floor – PCB Sample M2 collected from off-white textured paint near entryway.

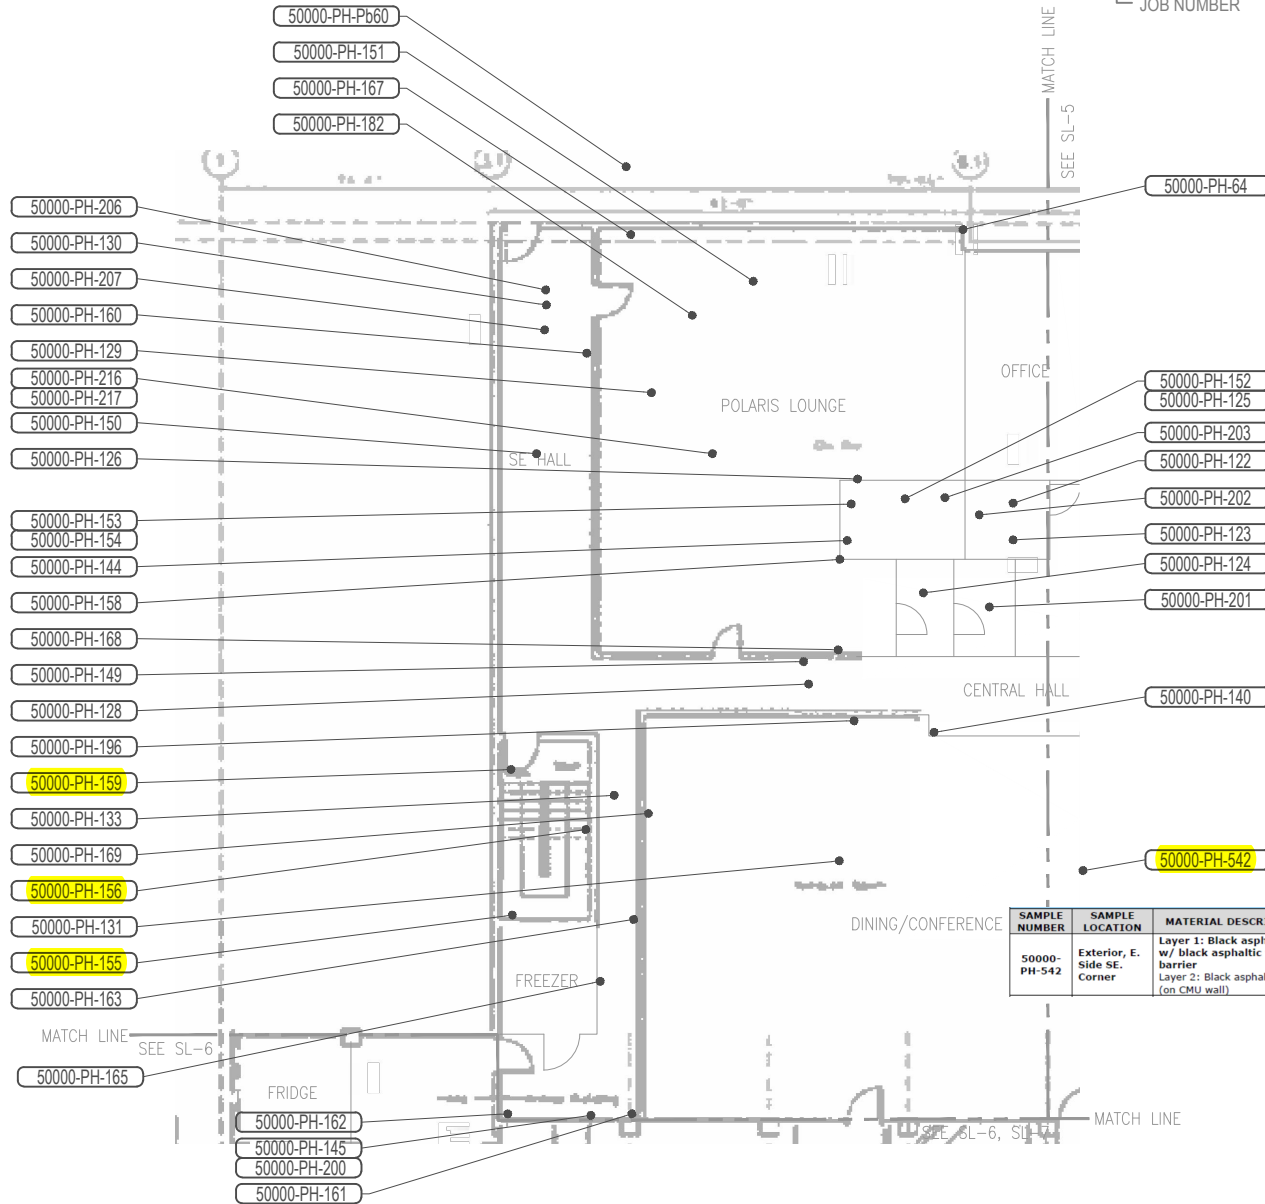
SL-4

SAMPLE NUMBER	SAMPLE LOCATION	MATERIAL DESCRIPTION	ASBESTOS %	TYPE OF ASBESTOS
50000-PH-542	Exterior, E. Side SE. Corner	Layer 1: Black asphaltic tar w/ black asphaltic vapor barrier Layer 2: Black asphaltic tar (on CMU wall)	L1: 3% L2: ND	Chrysotile N/A

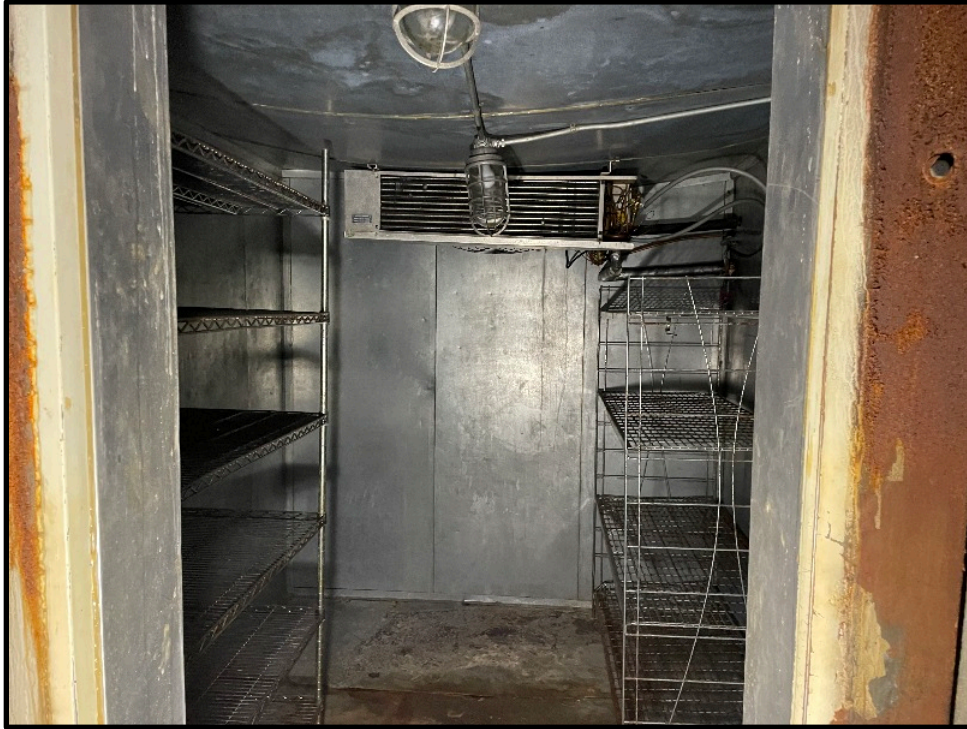
Photo 7: Walk-in freezer (R-5) – Ground floor

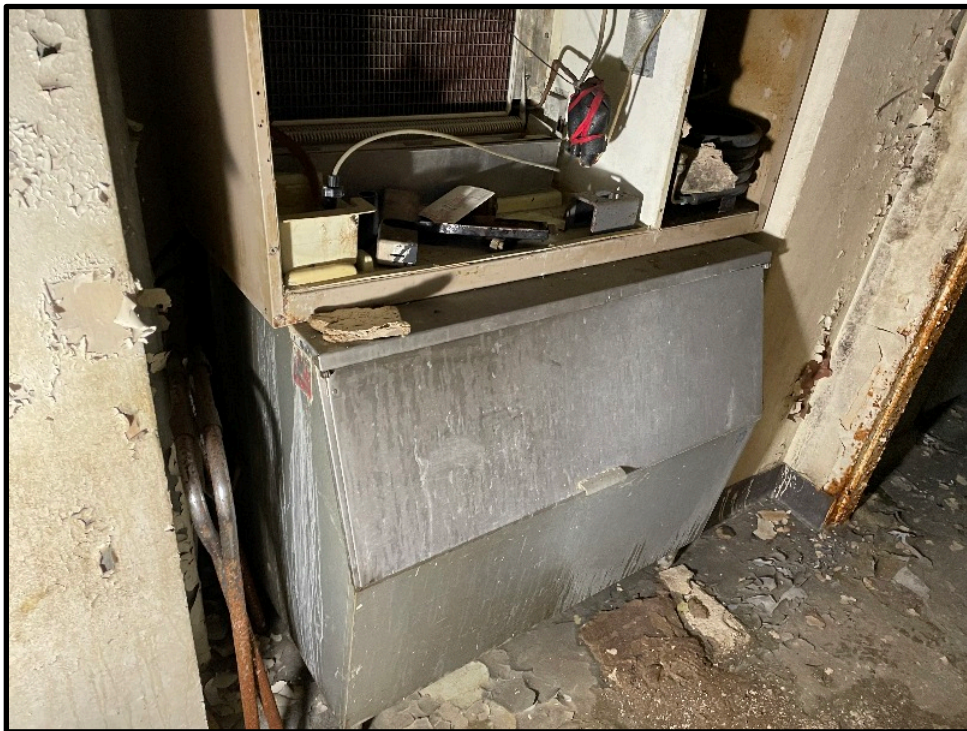
Photo 8: Ice machine (R-6) – Ground floor

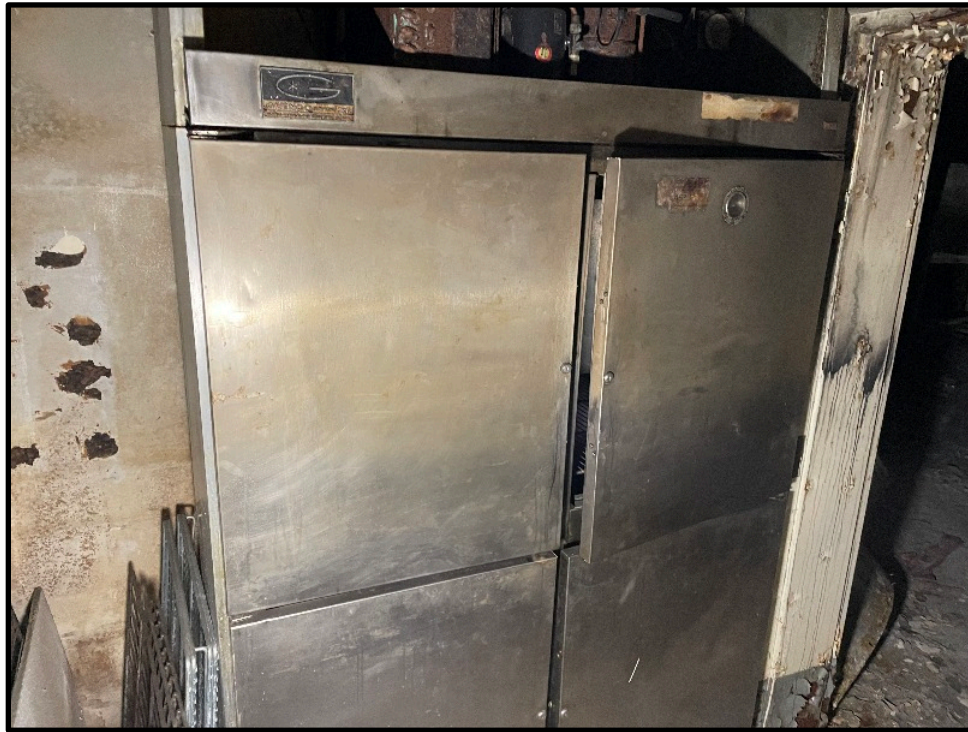
Photo 9: Standup refrigerator (R-7) – Ground floor

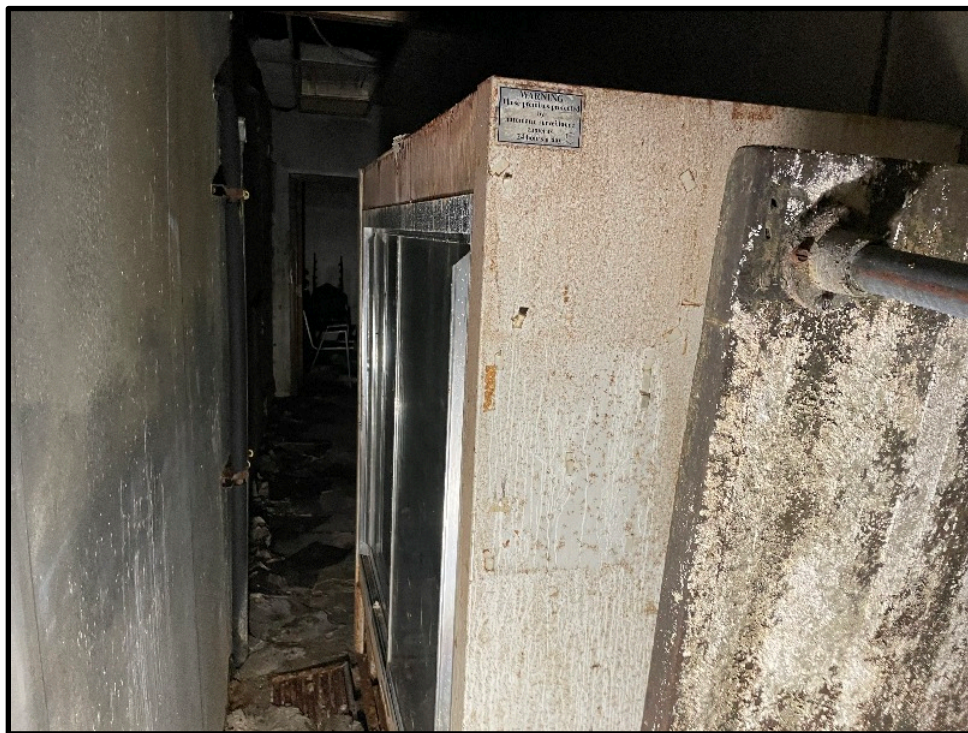
Photo 10: Glass display refrigerator (R-8) – Ground floor
