HAZARDOUS MATERIALS FAIRBANKS CITY HALL ROOF AND WINDOWS REPLACEMENT

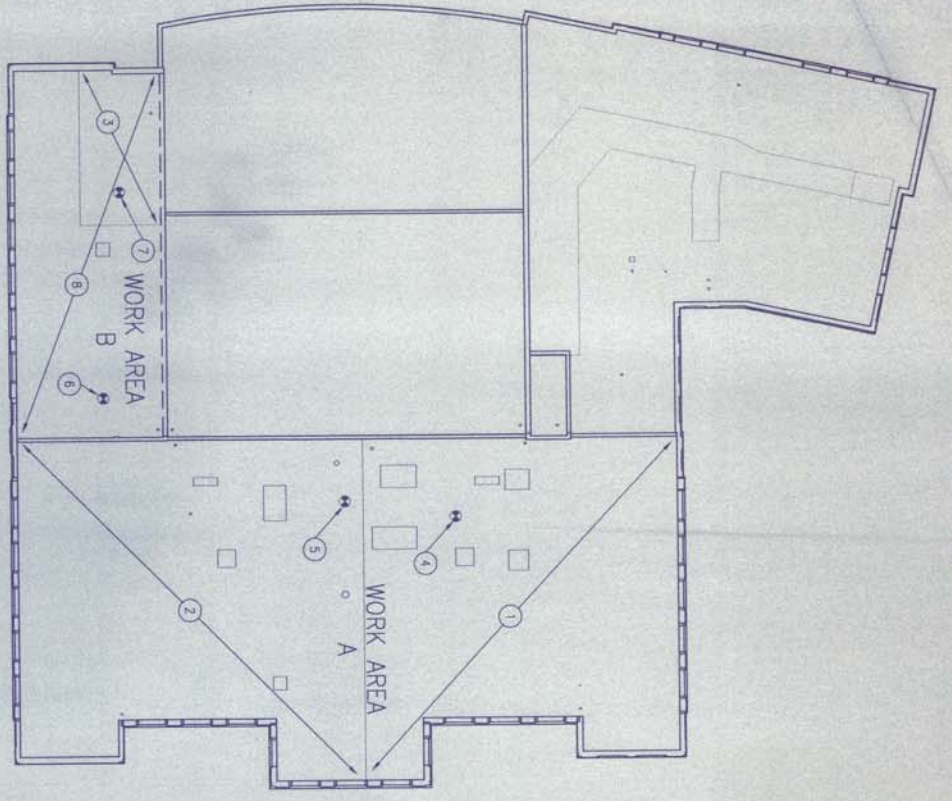
1 HAZARDOUS MATERIALS SAMPLE LOCATIONS
1/2" = 1'-0"

2. ASBESTOS
ASBESTOS CONTAINING MATERIAL (ACM) WAS DETECTED IN THE EXTERNAL WINDOW CASING. ACM SHALL BE DISPOSED OF IN AN ASBESTOS APPROVED LANDFILL SUCH AS THE FAIRBANKS NORTH STAR BROOKHOLM'S LANDFILL.
WORK DISTURBING ASBESTOS-CONTAINING WINDOW CASING WILL REQUIRE AIR MONITORING TO DOCUMENT WORKER EXPOSURE IN THE ABSENCE OF AN APPROVED NEGATIVE EXPOSURE ASSESSMENT (NEA).
WORKERS WHO WILL POTENTIALLY DISTURB ASBESTOS-CONTAINING CASING WILL BE REQUIRED TO ATTEND A MINIMUM 8 HOUR ASBESTOS-TRAINING CLASS.
ALL SAMPLES COLLECTED FROM THE ROOF AND UNDER THE ROOF IN THE ATTIC WERE FOUND NOT TO CONTAIN ASBESTOS. ROOFING SAMPLES WERE LABORATORY ANALYZED BY INDIVIDUAL LAYER AND COMPARED BY SECOND LABORATORY.
THE PRESENCE OF SNOW LIMITED THE VISUAL INSPECTION OF THE ROOF AND SAMPLING AREAS.
TYPICAL ROOF CONSTRUCTION IN WORK AREAS A AND B:
APPROXIMATELY 6 LAYERS OF FELT (2 PLY)
ASPHALT
3 LAYERS OF FELT
2" WETLITE

2" WETLITE
ORIGINAL ROOF 3-2" BLACK FELT
1.5" PERLITE
WOOD DECKING
3. LEAD BASED PAINT
MANY OF THE WINDOW COMPONENTS SAMPLED, INCLUDING BUT NOT LIMITED TO WINDOW SASHES, WINDOW FRAMES AND WINDOW COULISSES, CONTAIN LEAD BASED PAINT (LBP). ALL WINDOW COMPONENTS SAMPLED SHALL BE CONSIDERED TO CONTAIN LBP. THE WASTE STREAM IS TO BE SUBJECTED TO A TOLP TEST BEFORE DISPOSAL. IT IS EXPECTED THAT THE TOLP WILL PASS AND WILL BE ABLE TO BE DISPOSSED OF AS NON-HAZARDOUS WASTE.
AIR MONITORING SHALL BE PERFORMED DURING THE REMOVAL PROCESS IN ORDER TO DOCUMENT THE LEVEL OF AN APPROVED NEGATIVE EXPOSURE AT A MINIMUM AND LONGER IF THE EXPOSURE IS NEAR OR ABOVE THE ACTION LEVEL LISTED BY FEDERAL REGULATIONS.
WORKERS WHO WILL REMOVE, TRANSPORT, AND DISPOSE OF WINDOW COMPONENTS ARE REQUIRED TO HAVE A MINIMUM OF 2-HOUR LEAD ABSENCE TRAINING.
