## **Appendix C Hazardous Materials Figures and Data Polaris Tower – Fairbanks, Alaska**

**NORTECH** has compiled the existing hazardous materials data for the Polaris Tower for use as part of the demolition planning of this structure. This information is expected to be provided to prospective bidders as an appendix to Specification Section 801 that describes the requirements for abatement and/or demolition of these materials.

The potentially hazardous materials listed below are known or suspected to be present in the Polaris Tower. These have been identified through inspection and sampling and the sample locations and results are included in the attachments to this document.

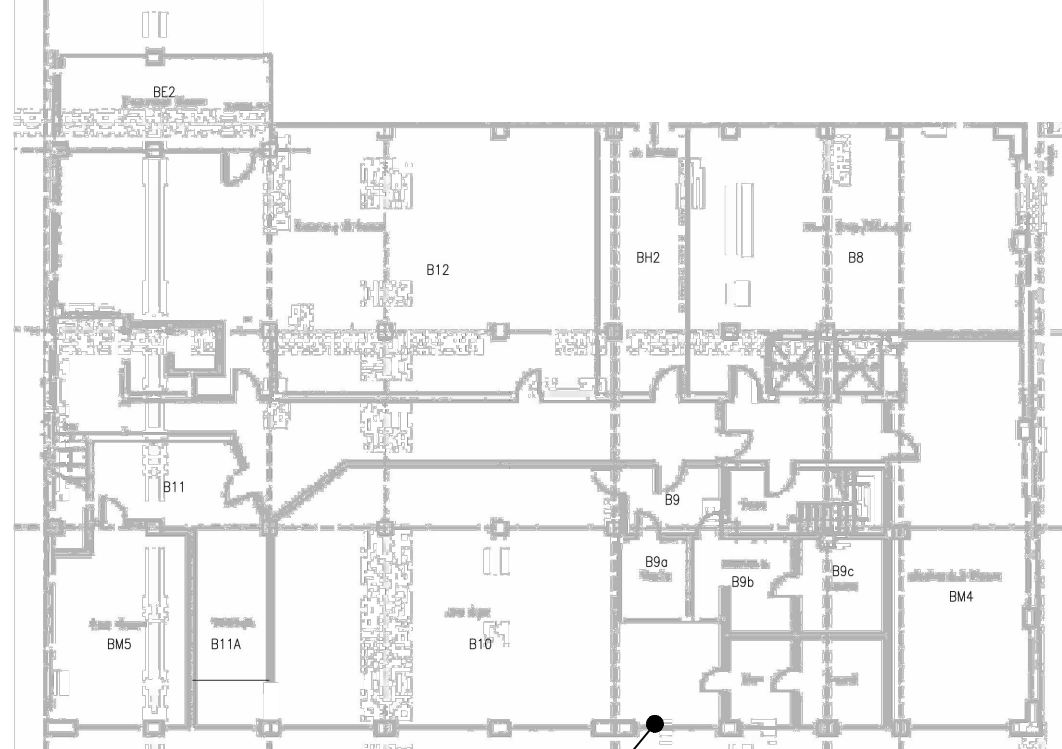
FIGURE  
**2**

**B4**  
4/21/2022  
EMSL

April 21, 2022 (EMSL)	
PCB Bulk by 3546/8082A (mg/Kg)	
Sample ID	B4
Color	green
Aroclor-1016	ND
Aroclor-1221	ND
Aroclor-1232	ND
Aroclor-1242	ND
Aroclor-1248	ND
Aroclor-1254	2.0
Aroclor-1260	ND
Aroclor-1262	ND
Aroclor-1268	ND

Basement PCB Sample Locations & Results  
 Polaris Hazardous Materials Investigation  
 Fairbanks, Alaska

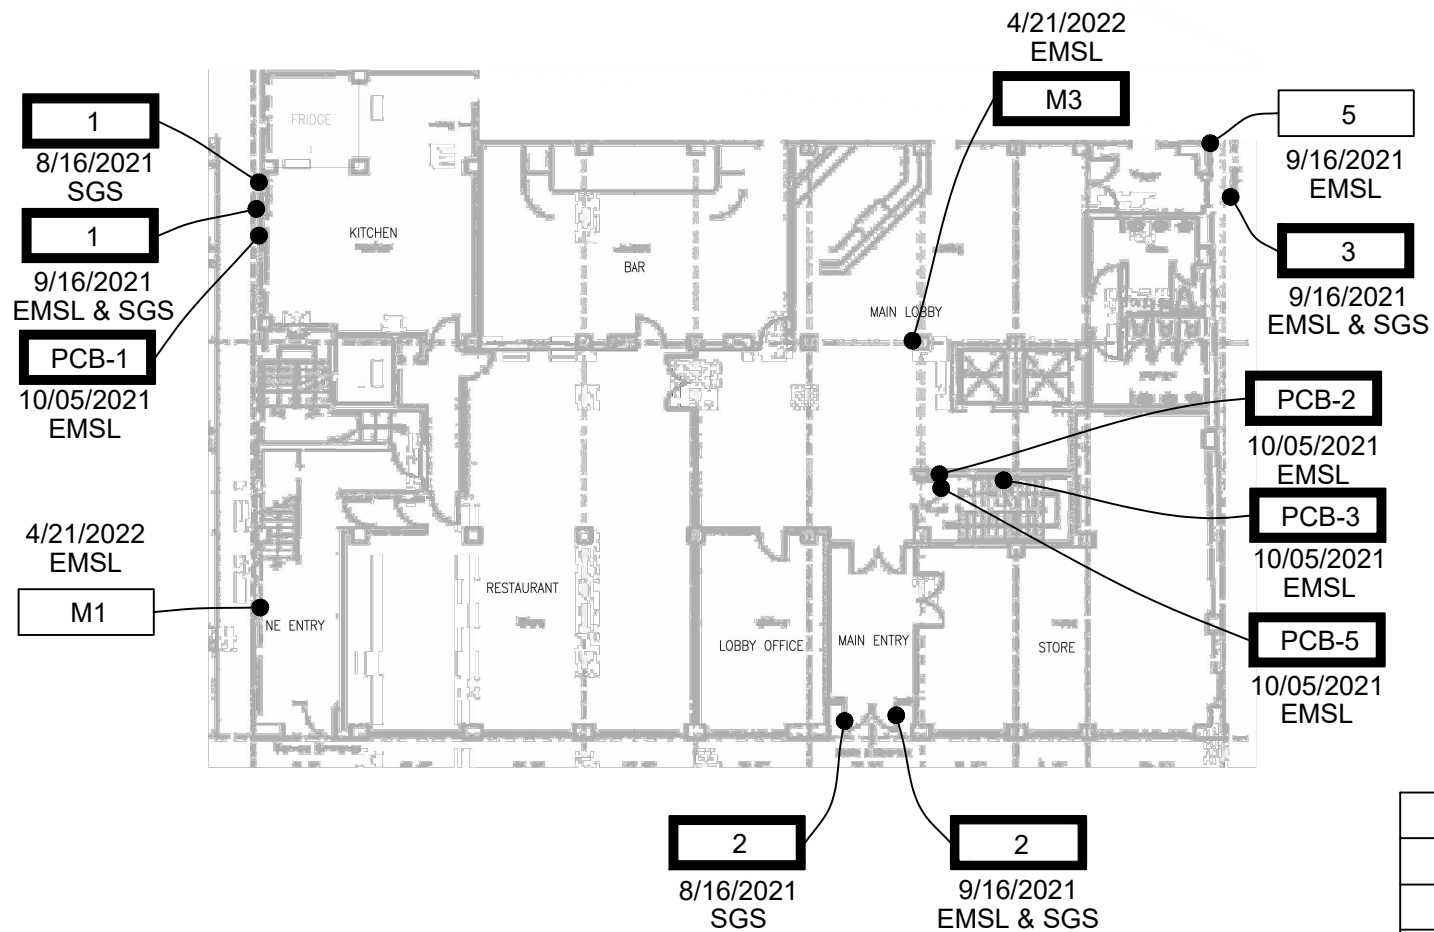
August 16, 2021 (SGS)		
PCB Bulk by 8082A (mg/Kg)		
Sample ID	1	2
Color	tan	green
Aroclor-1016	ND	ND
Aroclor-1221	ND	ND
Aroclor-1232	ND	ND
Aroclor-1242	ND	ND
Aroclor-1248	ND	ND
Aroclor-1254	431	ND
Aroclor-1260	104	155

September 16, 2021 (SGS)			
PCB Bulk by 8082A (mg/Kg)			
Sample ID	1	2	3
Color	tan	green	green
Aroclor-1016	ND	ND	ND
Aroclor-1221	ND	ND	ND
Aroclor-1232	ND	ND	ND
Aroclor-1242	ND	ND	ND
Aroclor-1248	ND	ND	ND
Aroclor-1254	343	ND	ND
Aroclor-1260	161	ND	51

Main Floor PCB Sample Locations & Results  
 Polaris Hazardous Materials Investigation  
 Fairbanks, Alaska

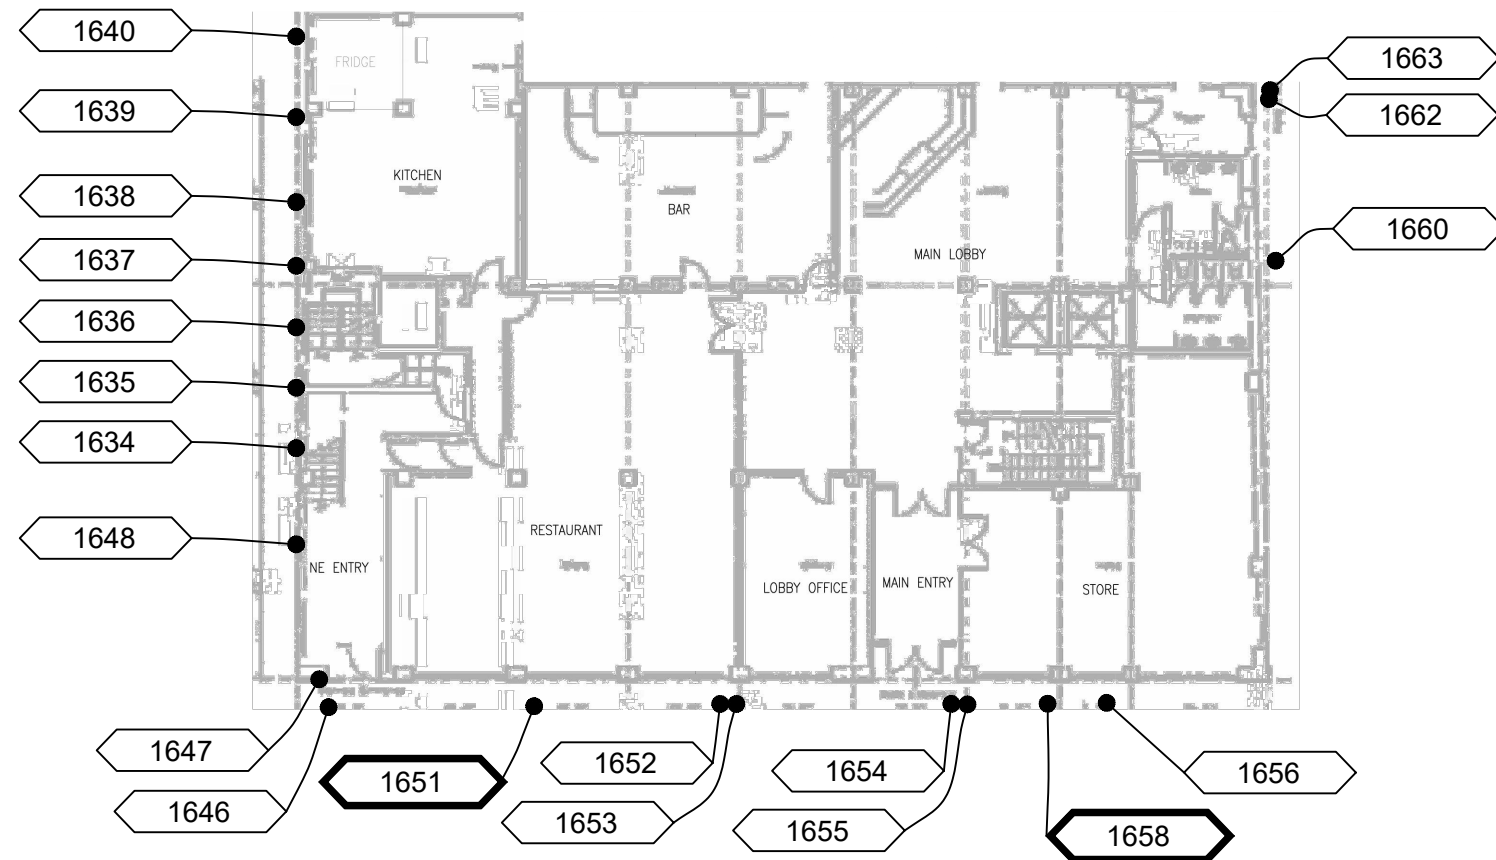
FIGURE  
4

Exterior				
Lead Sample Results				
Number	Color	Surface	Substrate	Result (mg/cm <sup>2</sup> )
1634	tan	wall	concrete	0.06
1635	tan	wall	concrete	0.4
1636	tan	wall	concrete	0.4
1637	tan	wall	concrete	0.4
1638	tan	wall	concrete	0.3
1639	tan	wall	concrete	0.07
1640	tan	wall	concrete	0.17
1646	green	ledge	concrete	0.9
1647	tan	wall	concrete	0.07
1648	tan	wall	concrete	0.12
1649	tan	wall	concrete	0.19
<b>1651</b>	<b>green</b>	<b>ledge</b>	<b>concrete</b>	<b>2.2</b>
1652	green	ledge	concrete	0.6
1653	green	ledge	concrete	0.6
1654	green	ledge	concrete	0.6
1655	green	ledge	concrete	0.24
1656	green	ledge	concrete	0.6
<b>1658</b>	<b>green</b>	<b>window</b>	<b>wood</b>	<b>9.7</b>
1660	green	ledge	concrete	0.9
1662	green	ledge	concrete	0.12
1663	green	ledge	concrete	0.23

Main Floor Lead Sample Locations & Results  
 Polaris Hazardous Materials Investigation  
 Fairbanks, Alaska

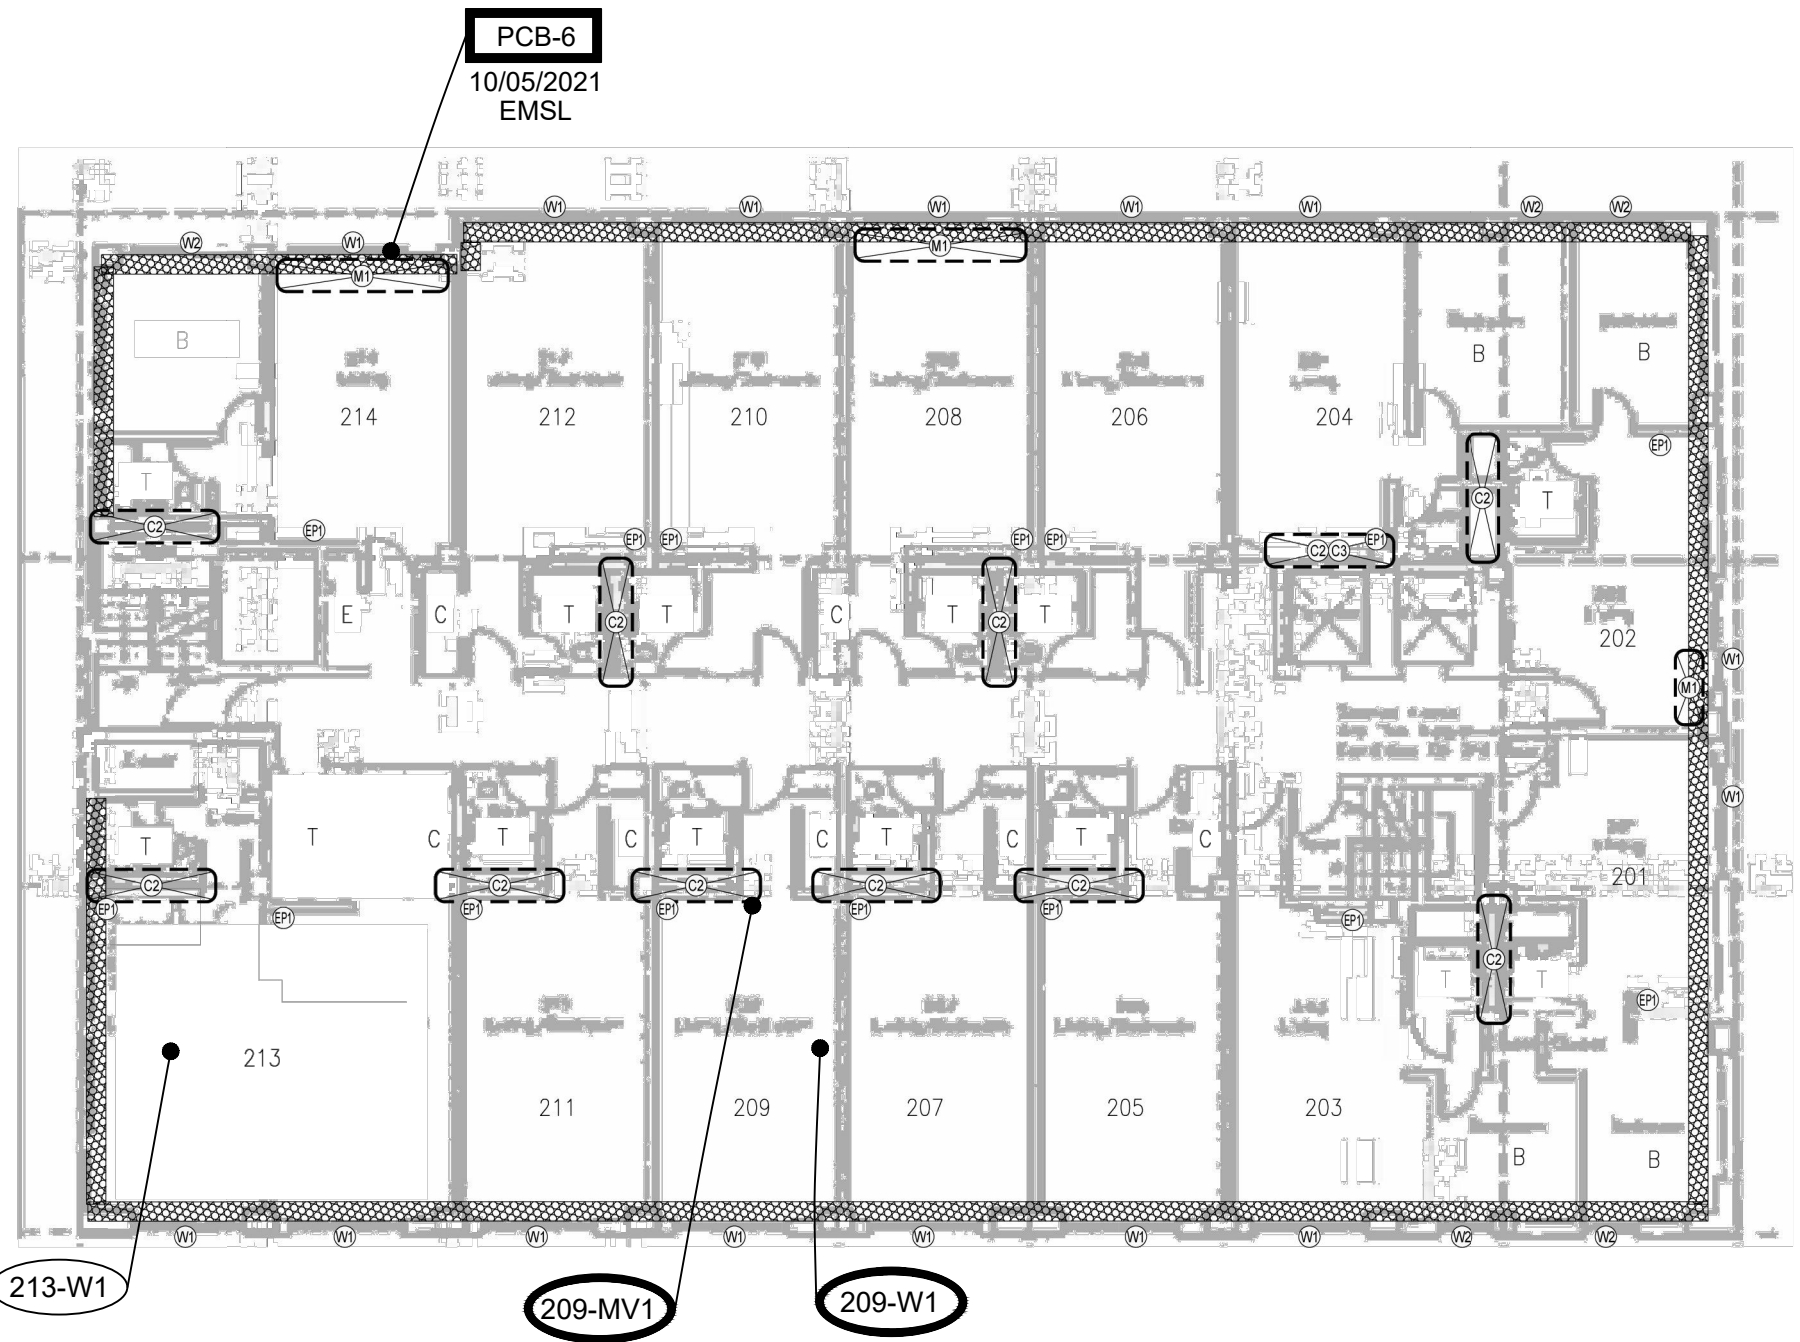
October 5, 2021 (EMSL)	
PCB Bulk by 3546/8082A (mg/Kg)	
Sample ID	PCB-6
Color	window caulk
Aroclor-1016	ND
Aroclor-1221	ND
Aroclor-1232	ND
Aroclor-1242	ND
Aroclor-1248	6.8
Aroclor-1254	6.8
Aroclor-1260	ND
Aroclor-1262	ND
Aroclor-1268	ND

Asbestos Microvac Sample	
ASTM D5755 (str/cm <sup>2</sup> )	
Sample ID	209-MV1
Surface	floor - carpet
Result	42,800

3rd Floor PCB Sample Locations & Results  
 Polaris Hazardous Materials Investigation  
 Fairbanks, Alaska

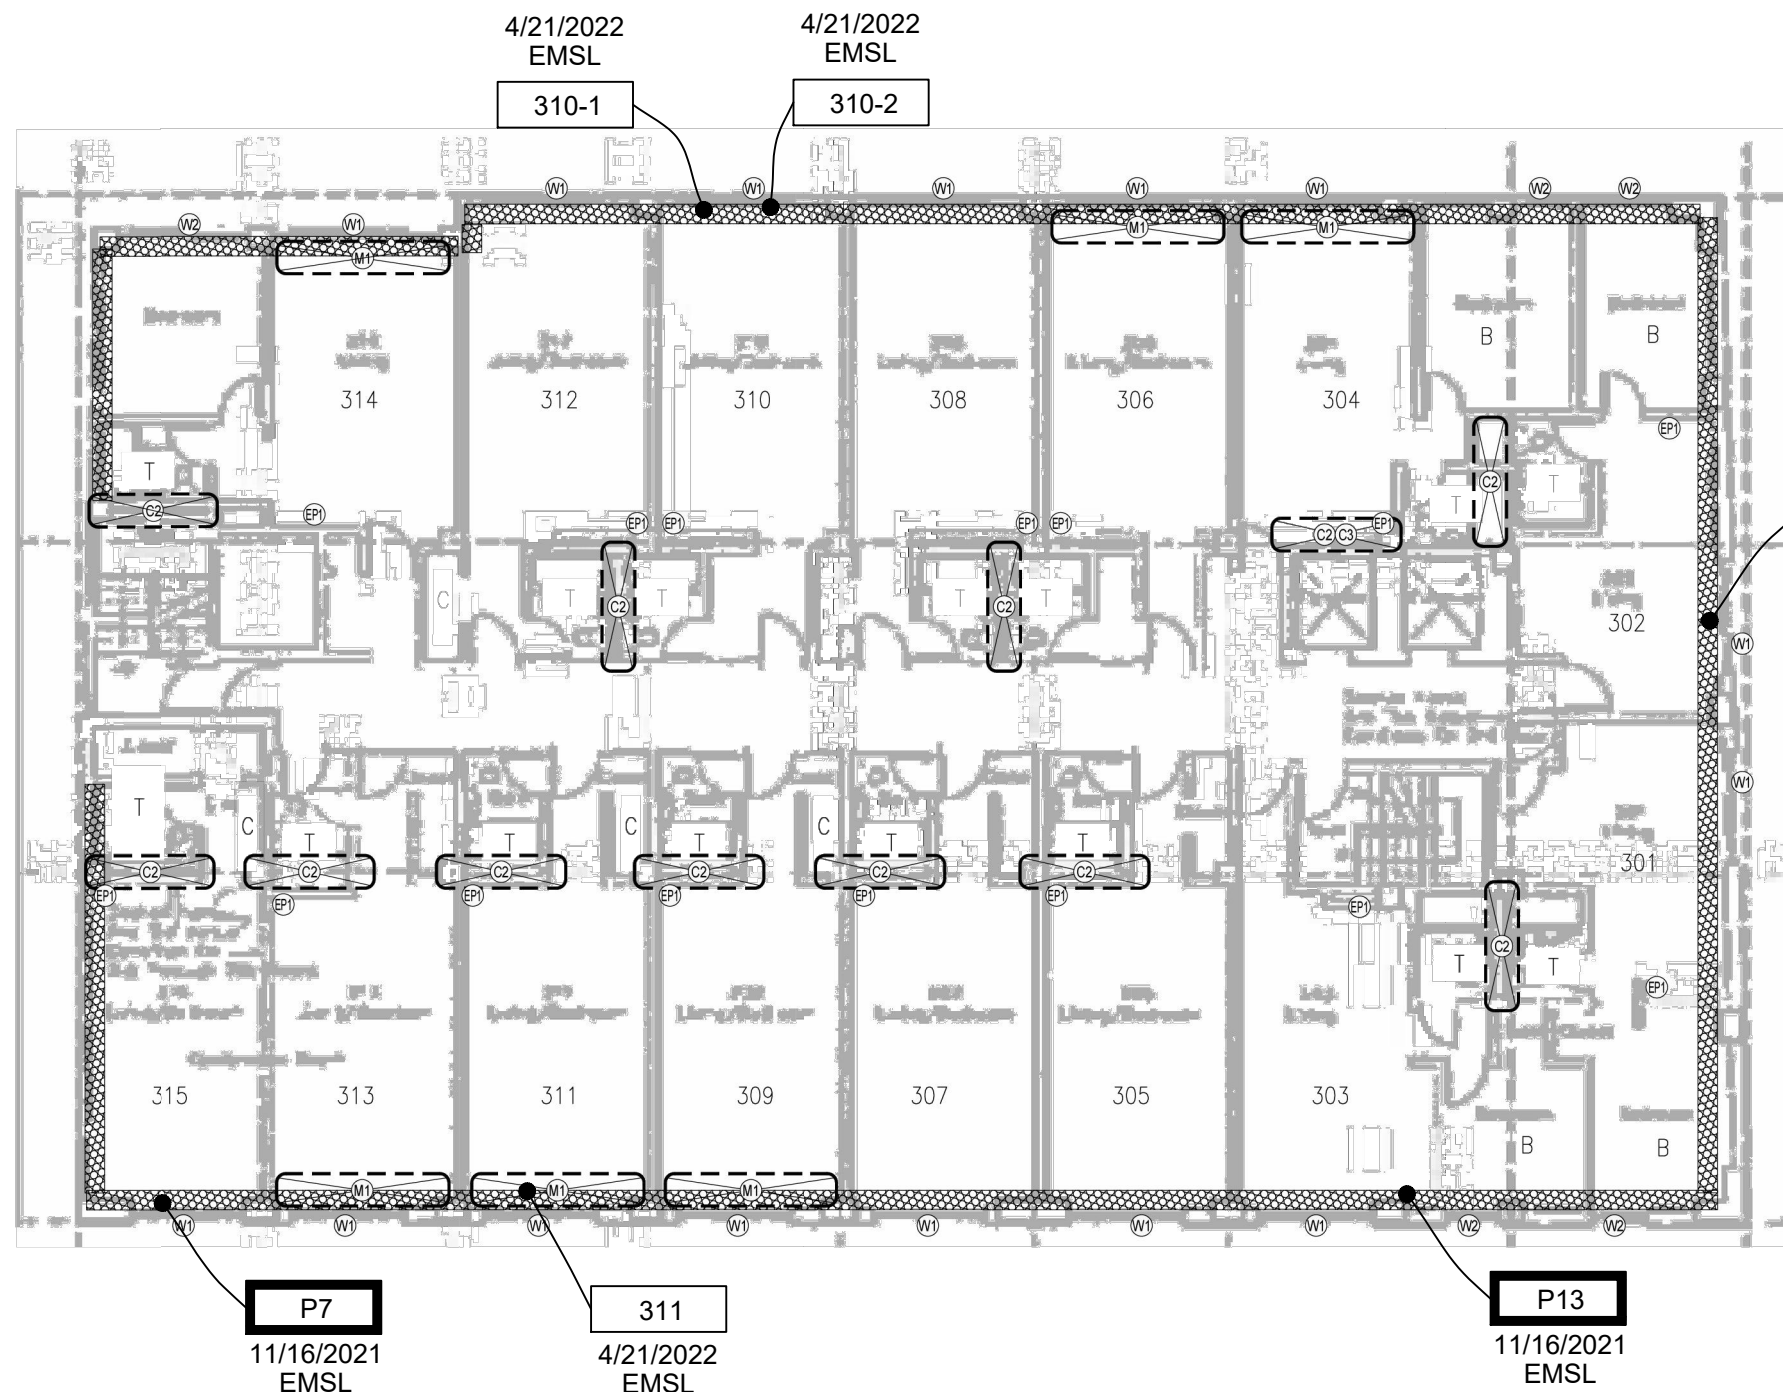
FIGURE  
**7**

November 16, 2021 (EMSL)			
PCB Bulk by 3546/8082A (mg/Kg)			
Sample ID	P3	P13	P7
Color	tan	tan	tan
Aroclor-1016	ND	ND	ND
Aroclor-1221	ND	ND	ND
Aroclor-1232	ND	ND	ND
Aroclor-1242	ND	ND	ND
Aroclor-1248	ND	ND	ND
Aroclor-1254	11	14	20
Aroclor-1260	1.3	ND	ND
Aroclor-1262	ND	ND	ND
Aroclor-1268	ND	ND	ND

April 21, 2022 (EMSL)			
PCB Bulk by 3546/8082A (mg/Kg)			
Sample ID	310-1	310-2	311
Color	unpainted concrete	unpainted concrete	unpainted concrete
Aroclor-1016	ND	ND	ND
Aroclor-1221	ND	ND	ND
Aroclor-1232	ND	ND	ND
Aroclor-1242	ND	ND	ND
Aroclor-1248	ND	ND	ND
Aroclor-1254	ND	ND	ND
Aroclor-1260	ND	ND	ND
Aroclor-1262	ND	ND	ND
Aroclor-1268	ND	ND	ND

4th Floor PCB Sample Locations & Results  
 Polaris Hazardous Materials Investigation  
 Fairbanks, Alaska

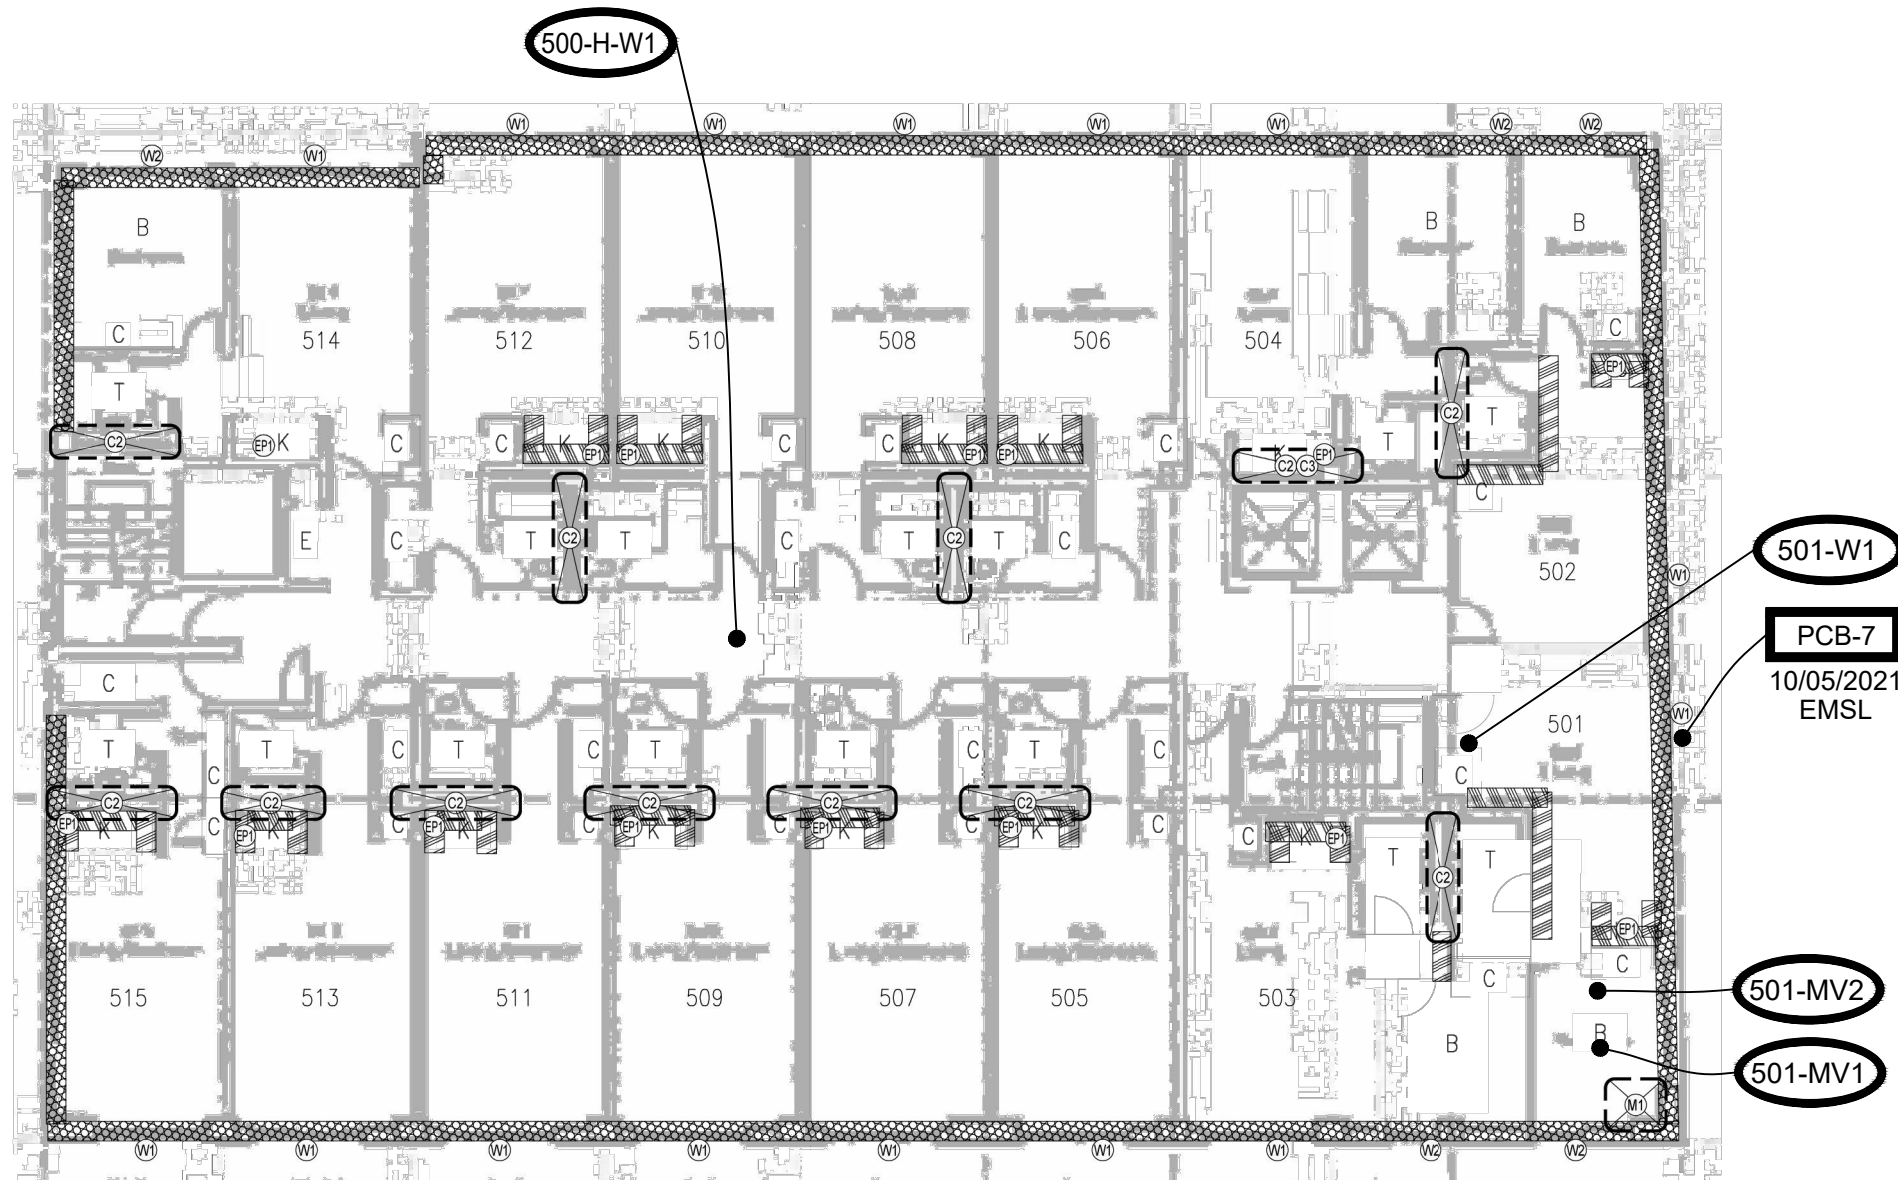
October 5, 2021 (EMSL)	
PCB Bulk by 3546/8082A (mg/Kg)	
Sample ID	PCB-7
Description	window caulk
Aroclor-1016	ND
Aroclor-1221	ND
Aroclor-1232	ND
Aroclor-1242	ND
Aroclor-1248	ND
Aroclor-1254	3.6
Aroclor-1260	ND
Aroclor-1262	ND
Aroclor-1268	ND

Asbestos Microvac Sample		
ASTM D5755 (str/cm <sup>2</sup> )		
Sample ID	501-MV1	501-MV2
Surface	bed sheet	floor - carpet
Result	12,200	4,120

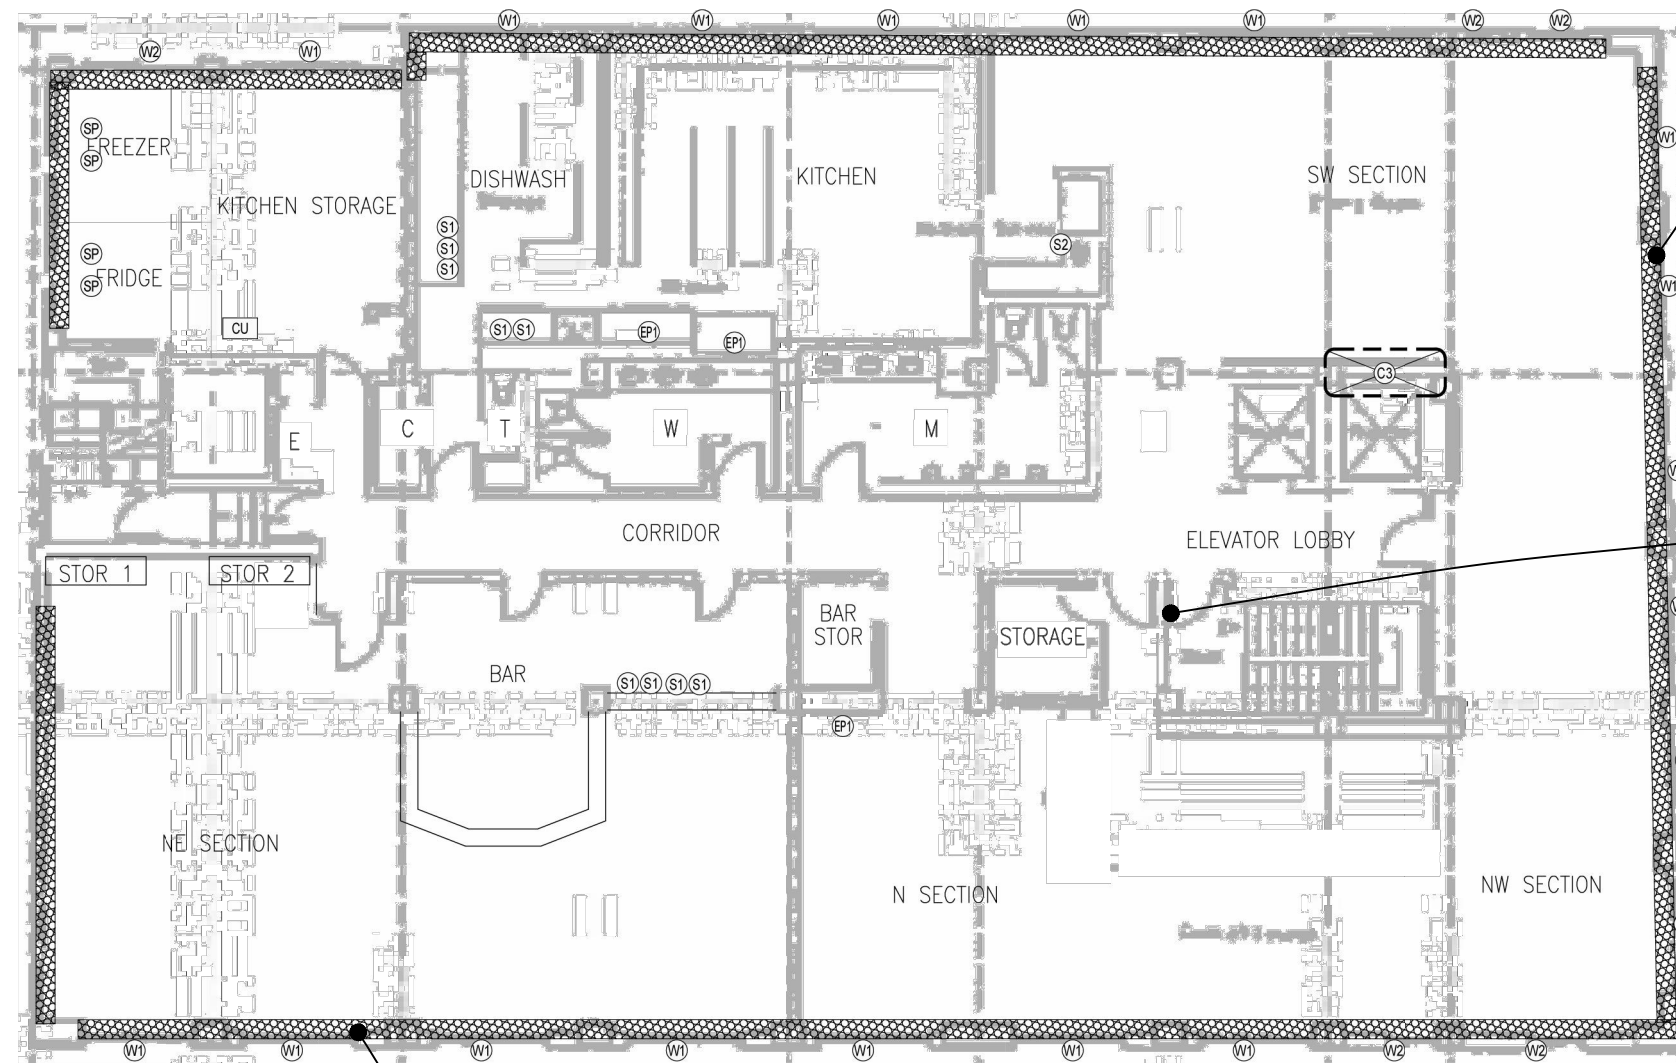
**P6**  
11/16/2021  
EMSL

**P4**  
11/16/2021  
EMSL

Penthouse PCB Sample Locations & Results  
Polaris Hazardous Materials Investigation  
Fairbanks, Alaska

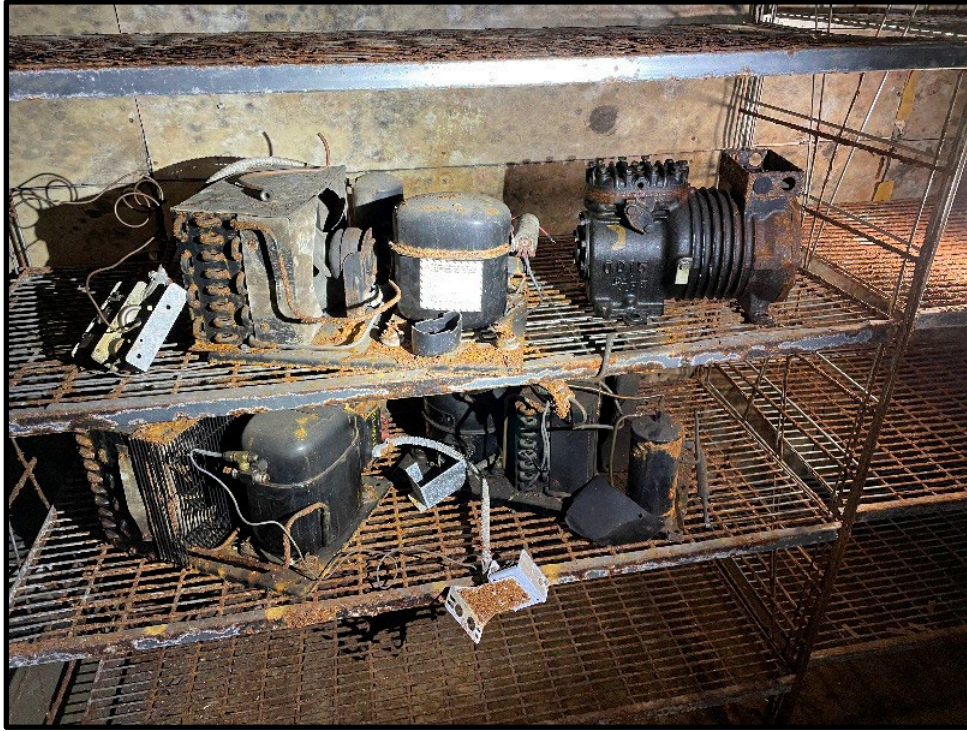
**Photo 1:** Refrigeration / air conditioner parts (R-1) - Basement

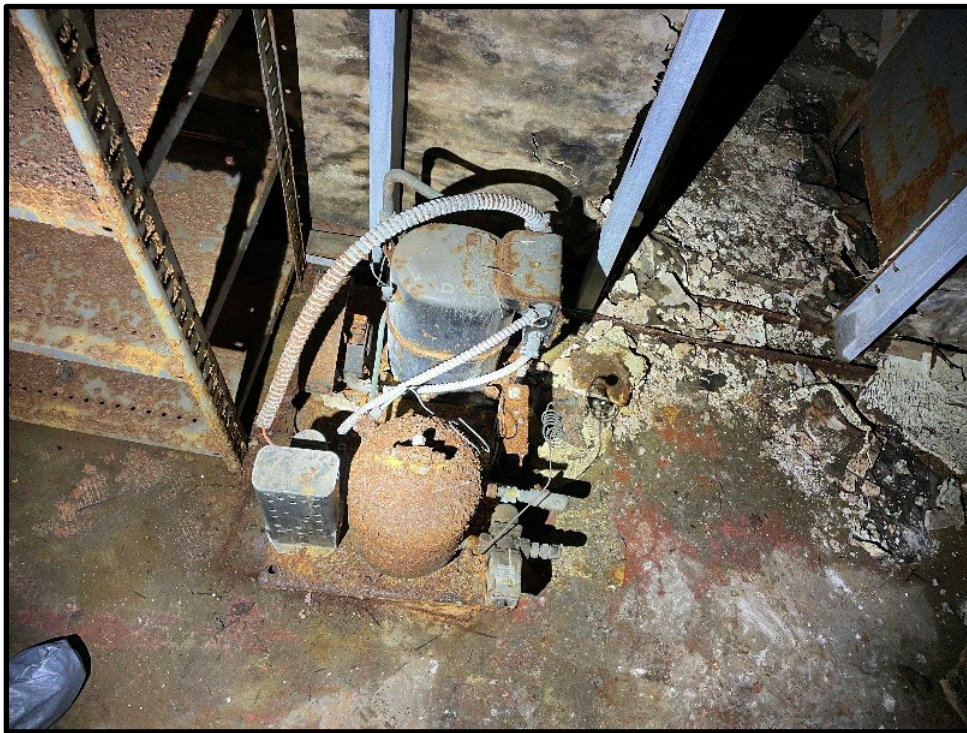
**Photo 2:** Refrigeration / air conditioner parts (R-1) - Basement

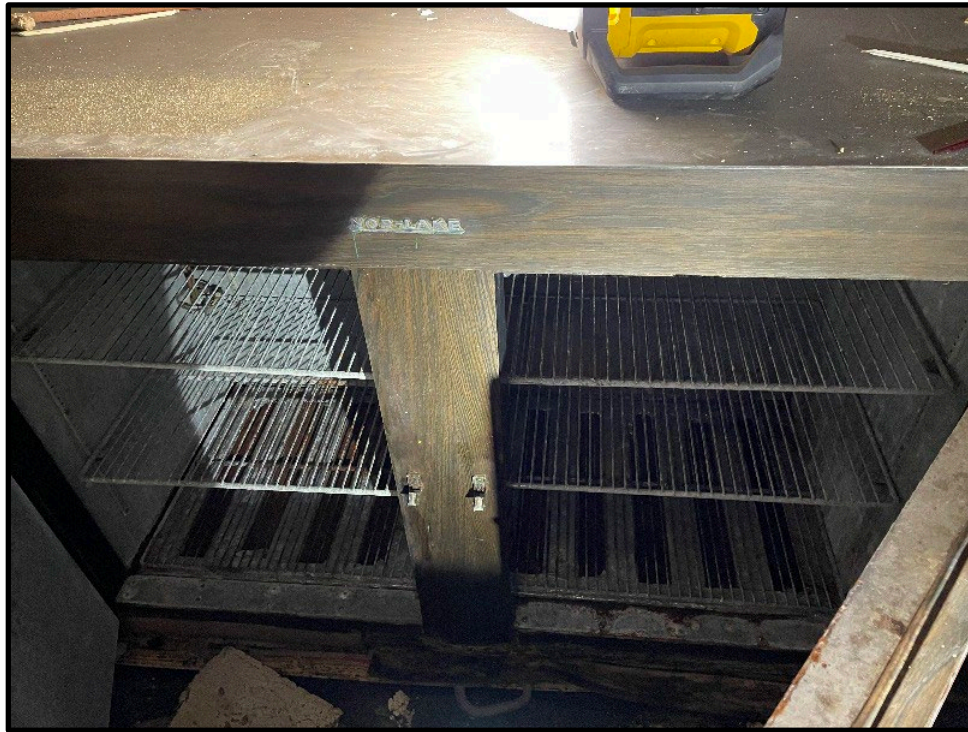
*Photo 3: Typical under cabinet refrigerator (R-2) – Ground floor*

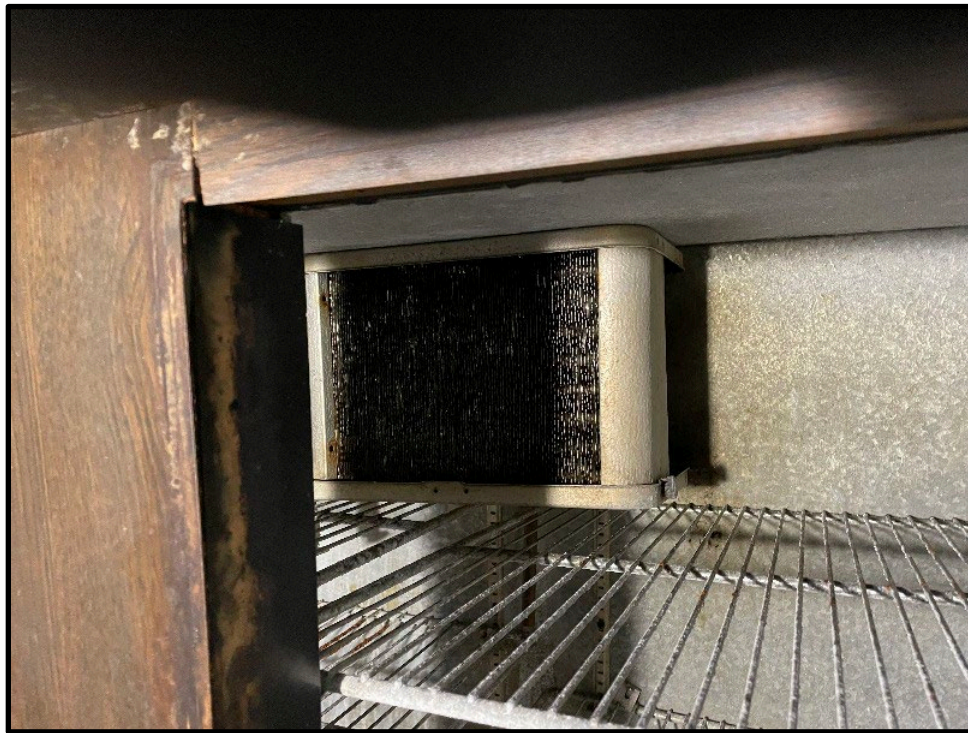
*Photo 4: Typical under cabinet refrigerator close-up (R-2) – Ground floor*

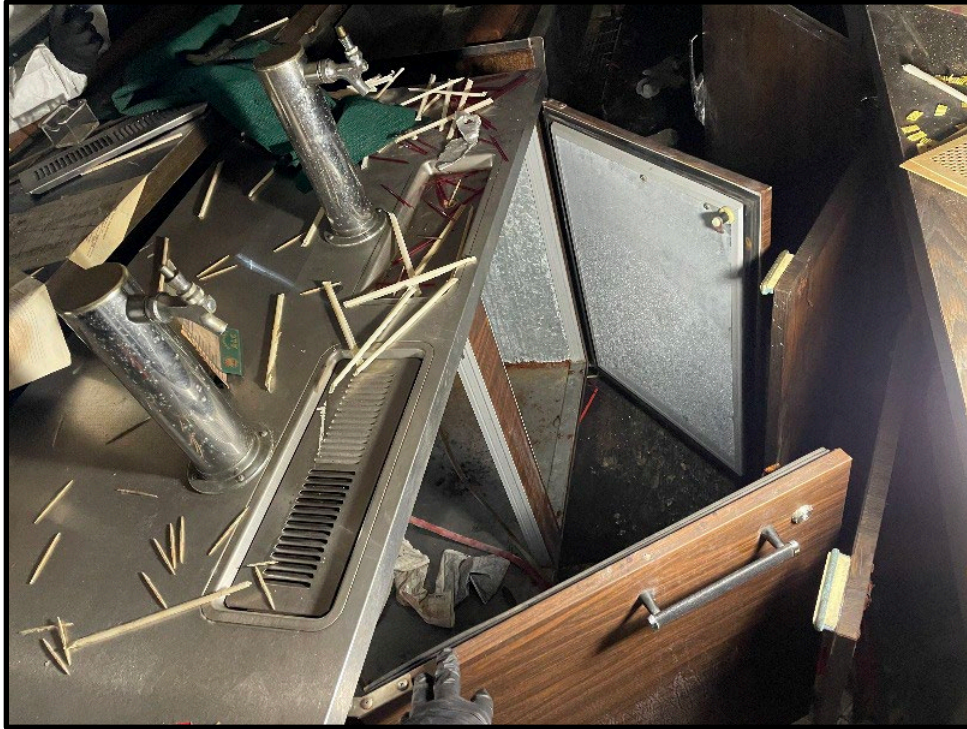
*Photo 5: Keg refrigerator (R-3) – Ground floor*

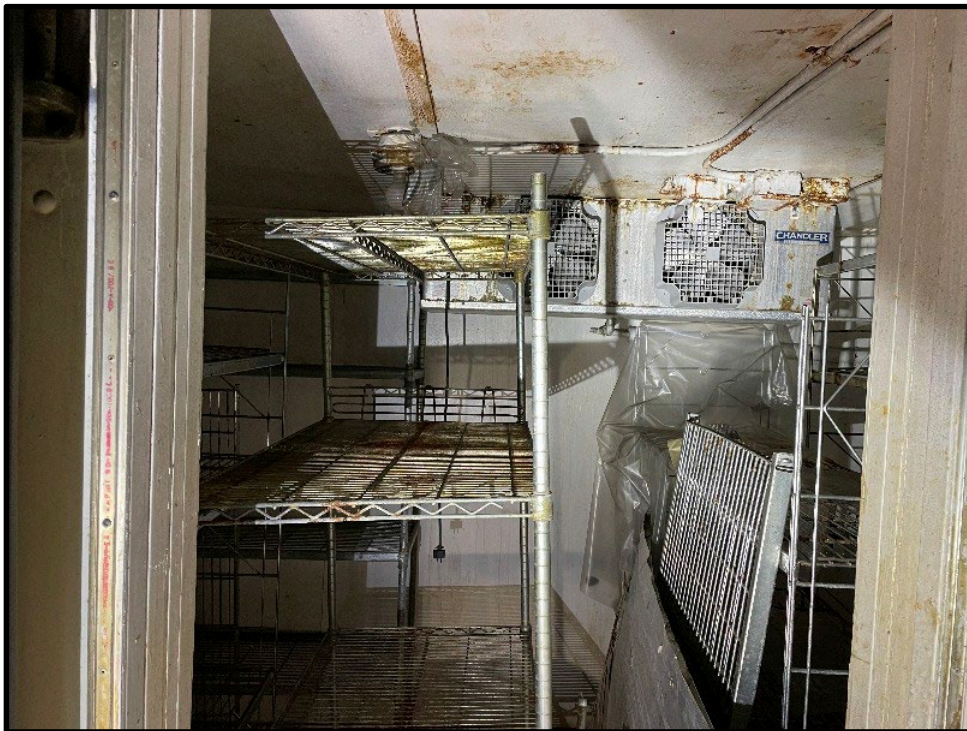
*Photo 6: Walk-in refrigerator (R-4) – Ground floor*

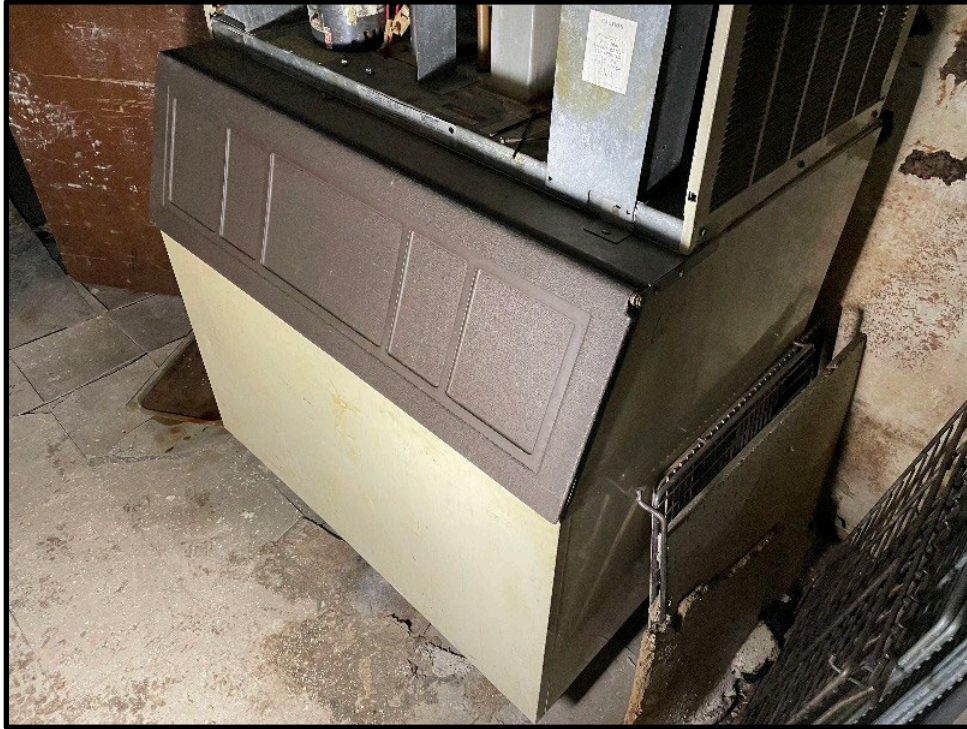
*Photo 7: Ice machine (R-9) – Ground floor*

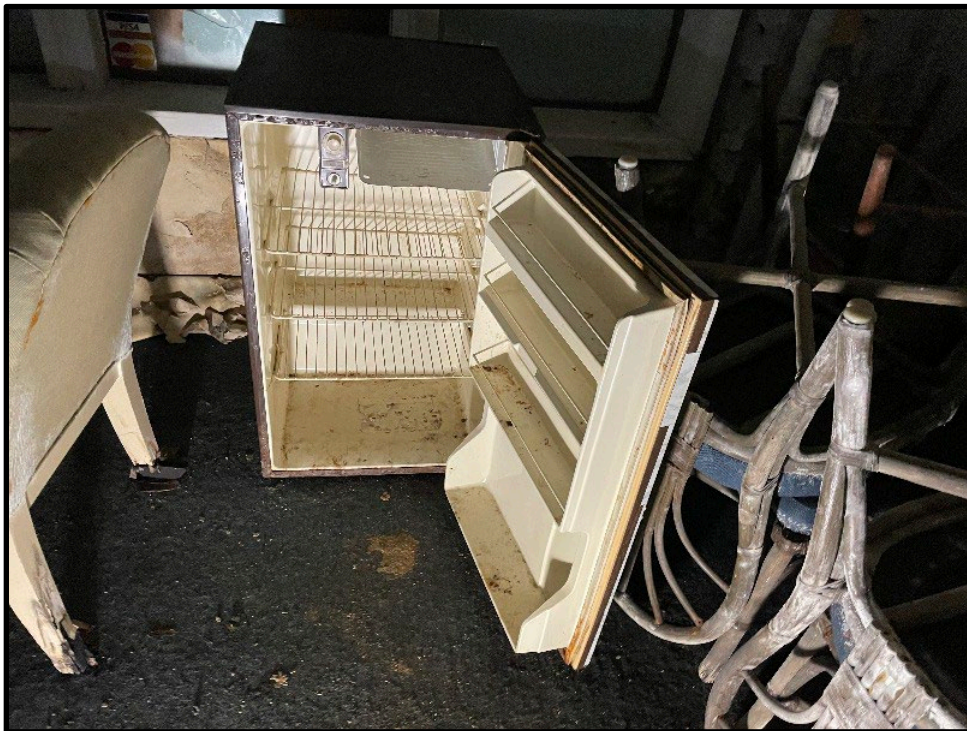
*Photo 8: Mini-fridge (R-10) – Ground Floor*

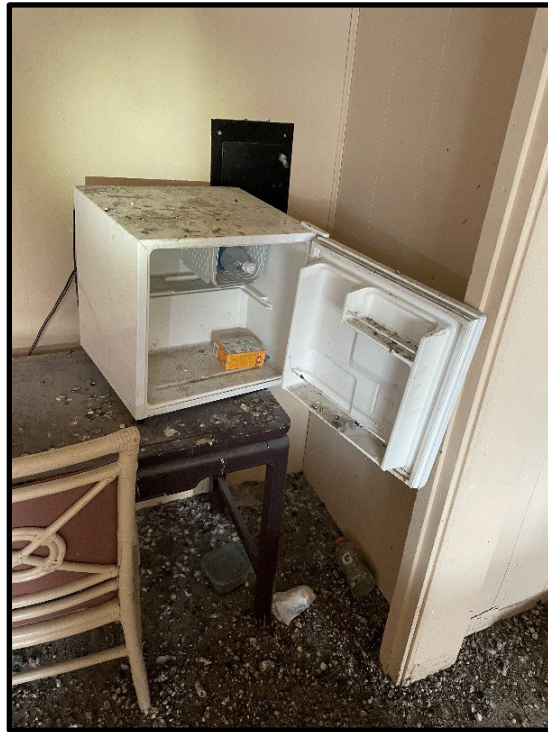
**Photo 9:** Mini-fridge (R-11) - 5<sup>th</sup> floor

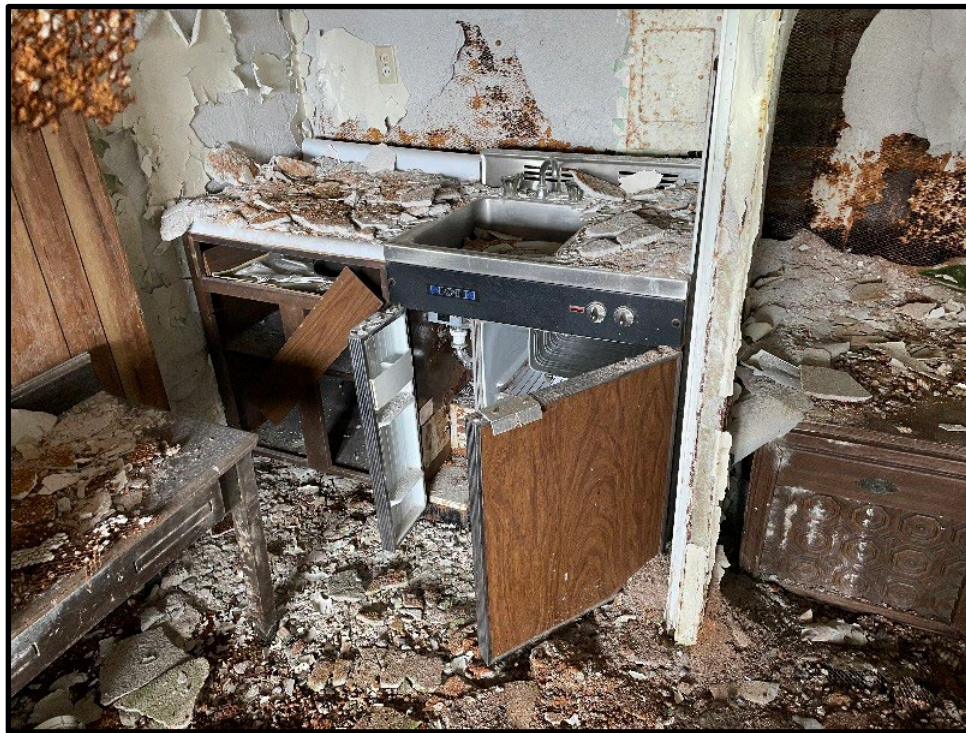
**Photo 10:** Mini-fridge / Kitchen unit (R-12) – 10<sup>th</sup> floor

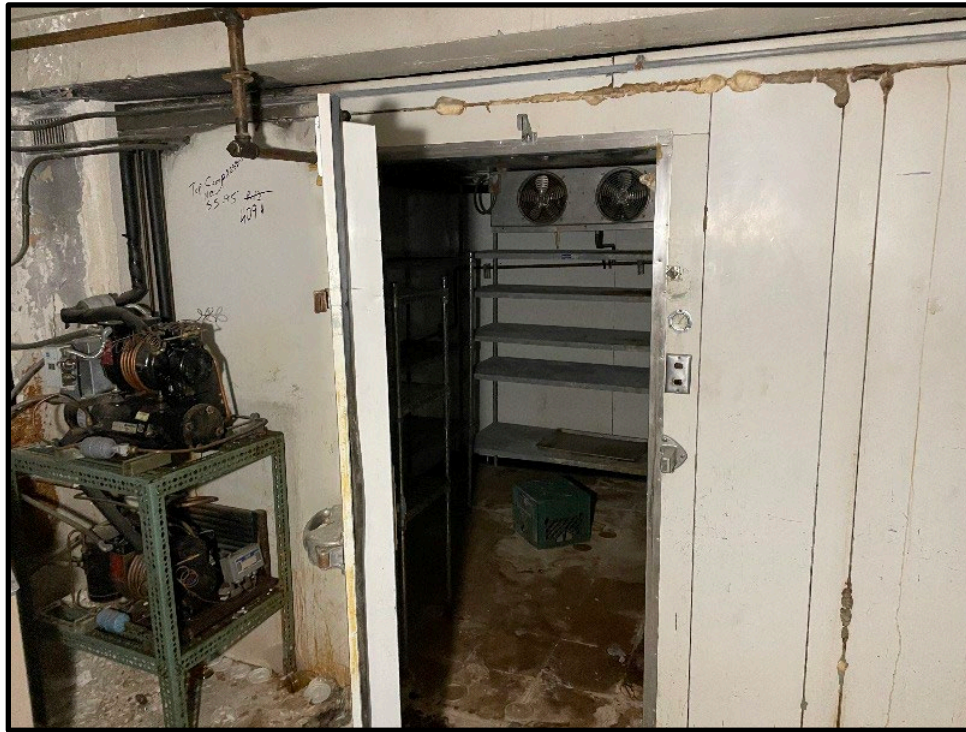
**Photo 11:** Walk-in refrigerator inside (R-13) – Penthouse floor

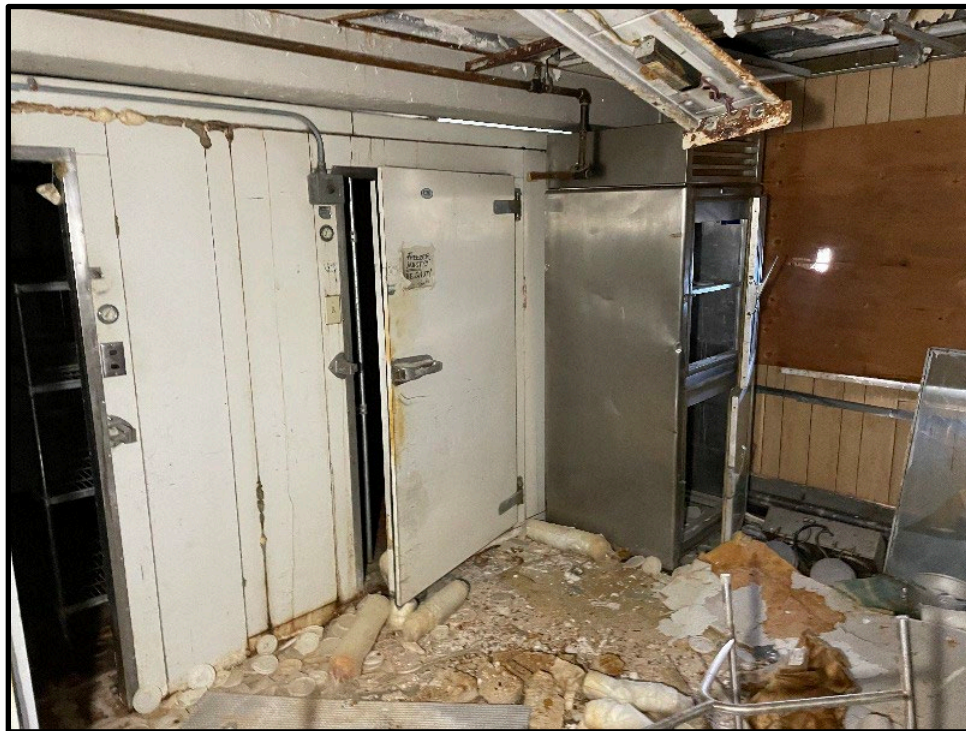
**Photo 12:** From left to right: walk-in refrigerator (R-13), walk-in freezer (R-14), standup refrigerator (R-15) – Penthouse floor

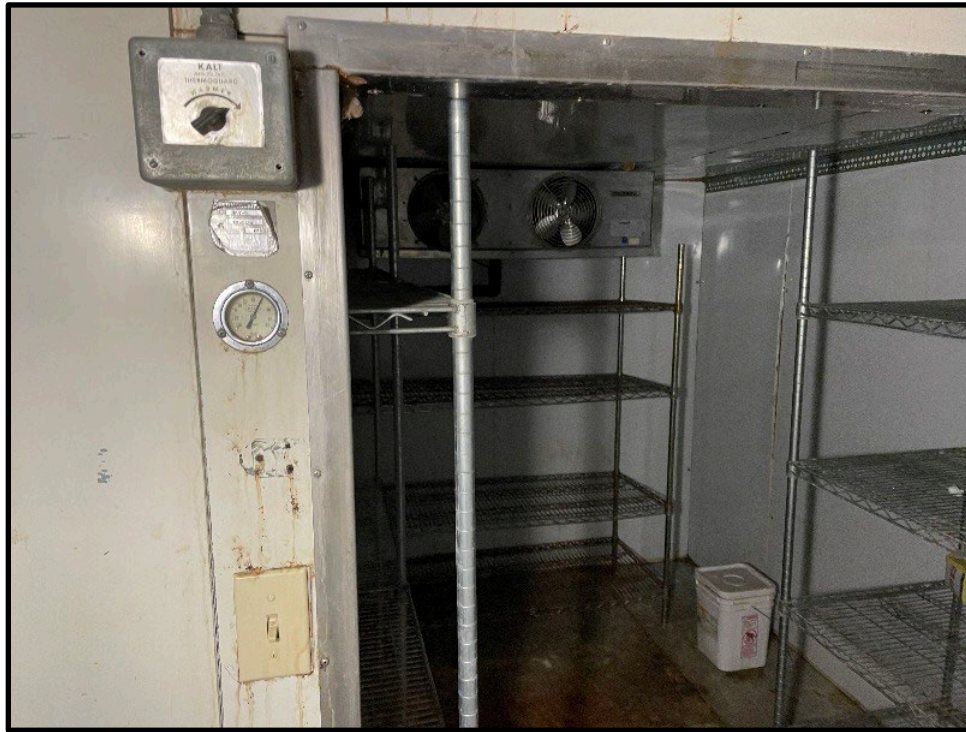
**Photo 13:** Walk-in freezer inside (R-14) – Penthouse floor
