## **Appendix C Hazardous Materials Figures and Data Polaris Tower – Fairbanks, Alaska**

**NORTECH** has compiled the existing hazardous materials data for the Polaris Tower for use as part of the demolition planning of this structure. This information is expected to be provided to prospective bidders as an appendix to Specification Section 801 that describes the requirements for abatement and/or demolition of these materials.

The potentially hazardous materials listed below are known or suspected to be present in the Polaris Tower. These have been identified through inspection and sampling and the sample locations and results are included in the attachments to this document.

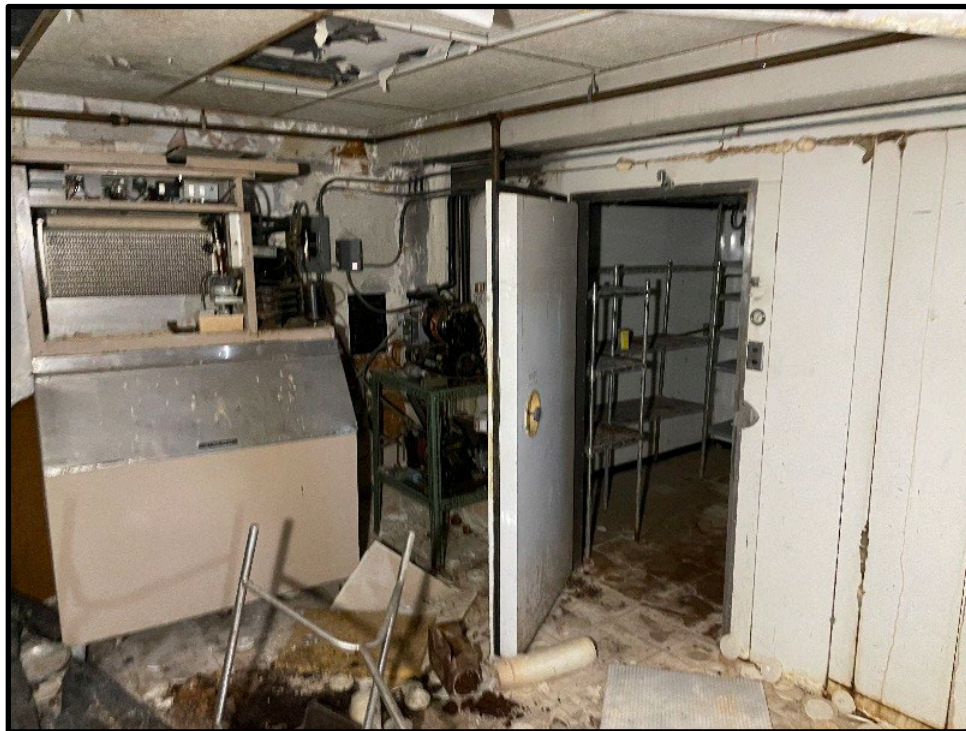
**Photo 14:** From left to right: Ice machine (R-16), walk-in refrigerator (R-13) – Penthouse floor

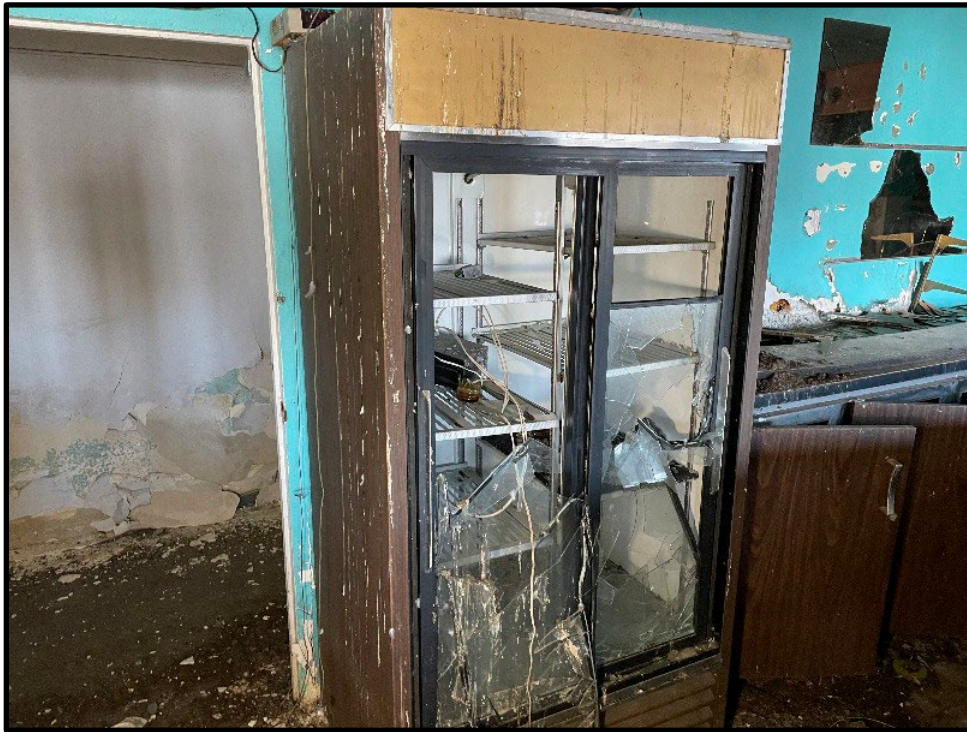
**Photo 15:** Glass display refrigerator (R-17) – Penthouse floor

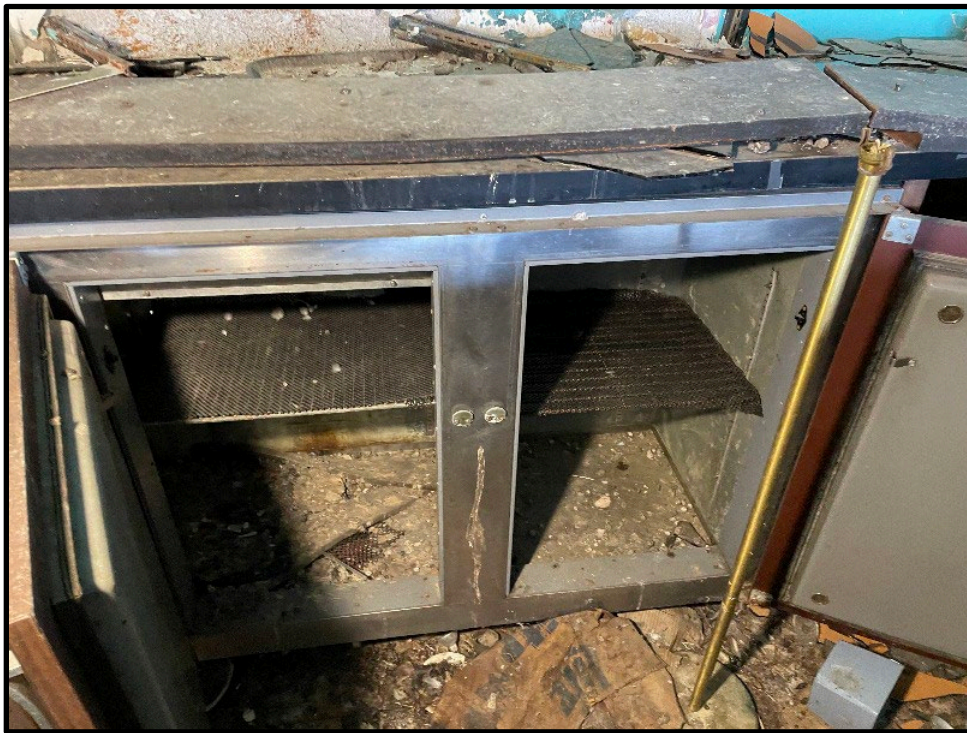
**Photo 16:** Under cabinet refrigerator (R-18) – Penthouse floor

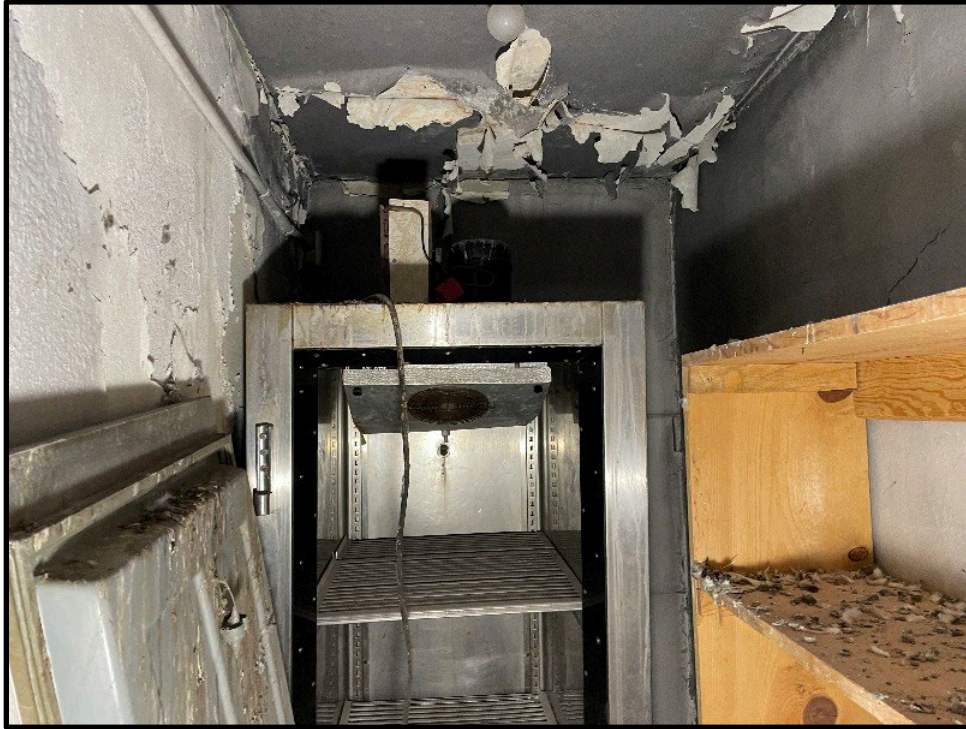
**Photo 17:** Standup refrigerator (top) (R-19) – Penthouse floor

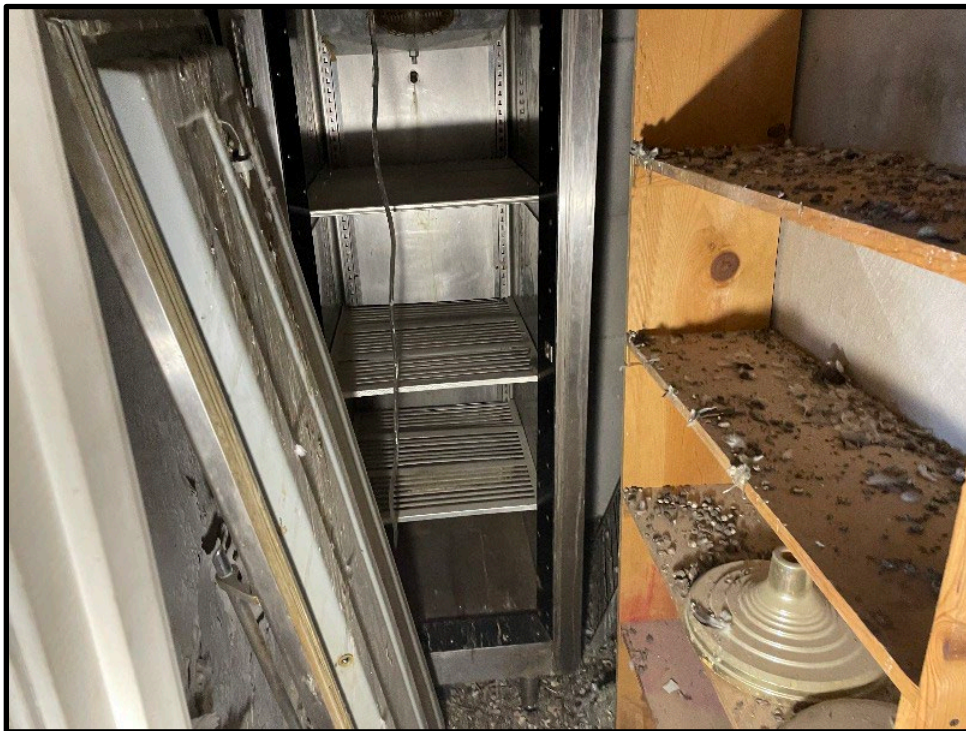
**Photo 18:** Standup refrigerator (bottom) (R-19) – Penthouse floor

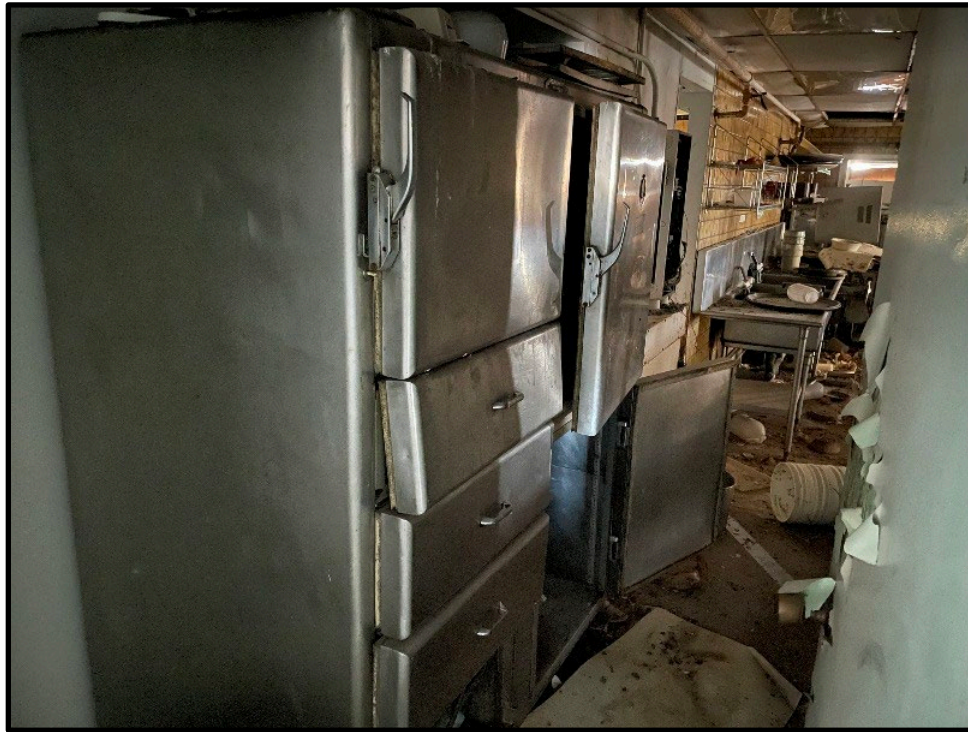
**Photo 19:** Double standup refrigerator (R-20) – Penthouse floor

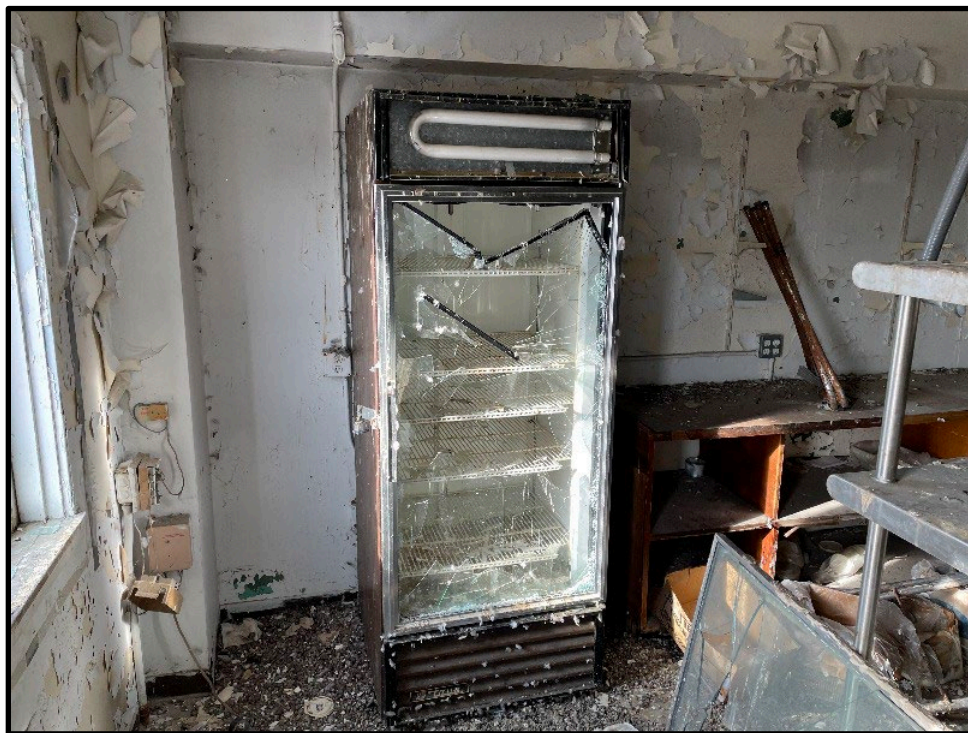
**Photo 20:** Glass display refrigerator (R-21) – Penthouse floor

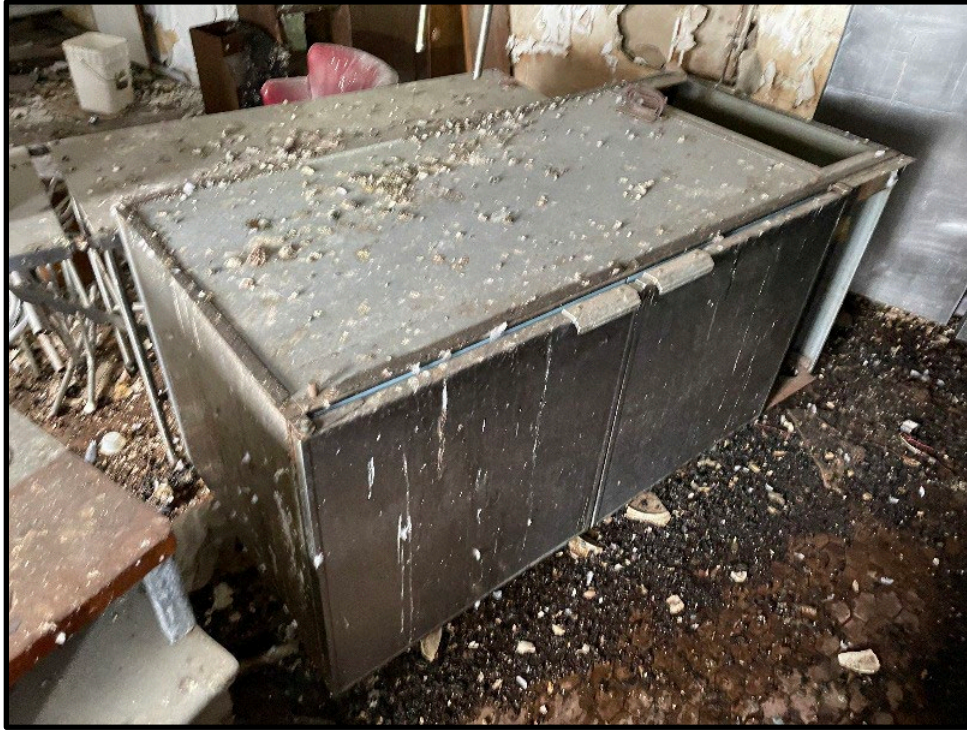
**Photo 21:** Chest freezer (R-22) – Penthouse floor

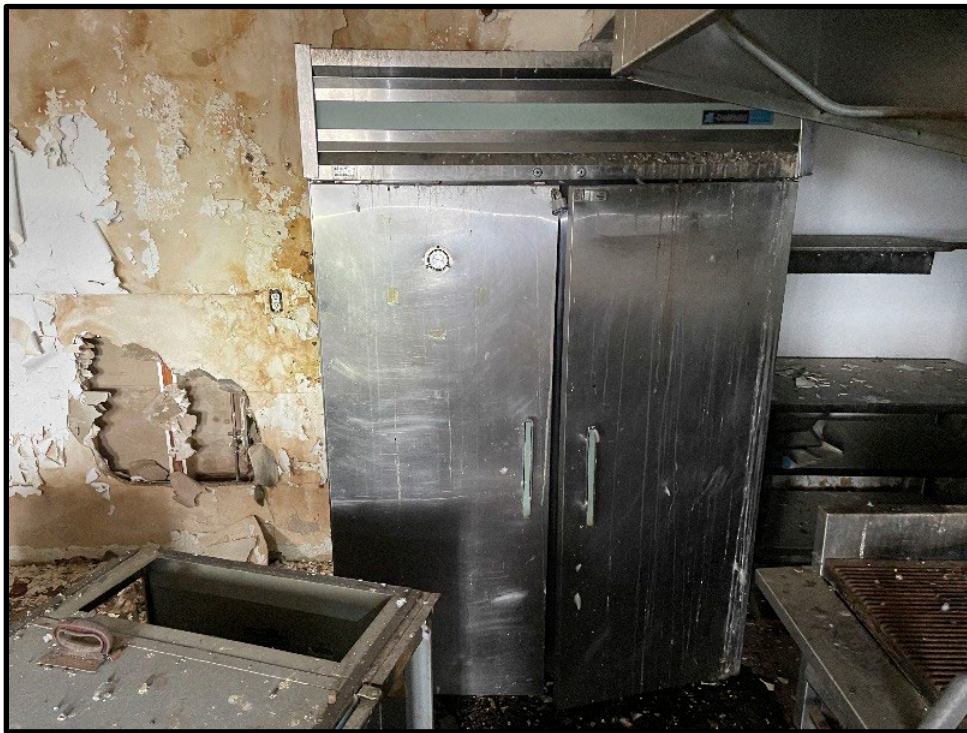
**Photo 22:** Standup refrigerator (R-23) – Penthouse floor

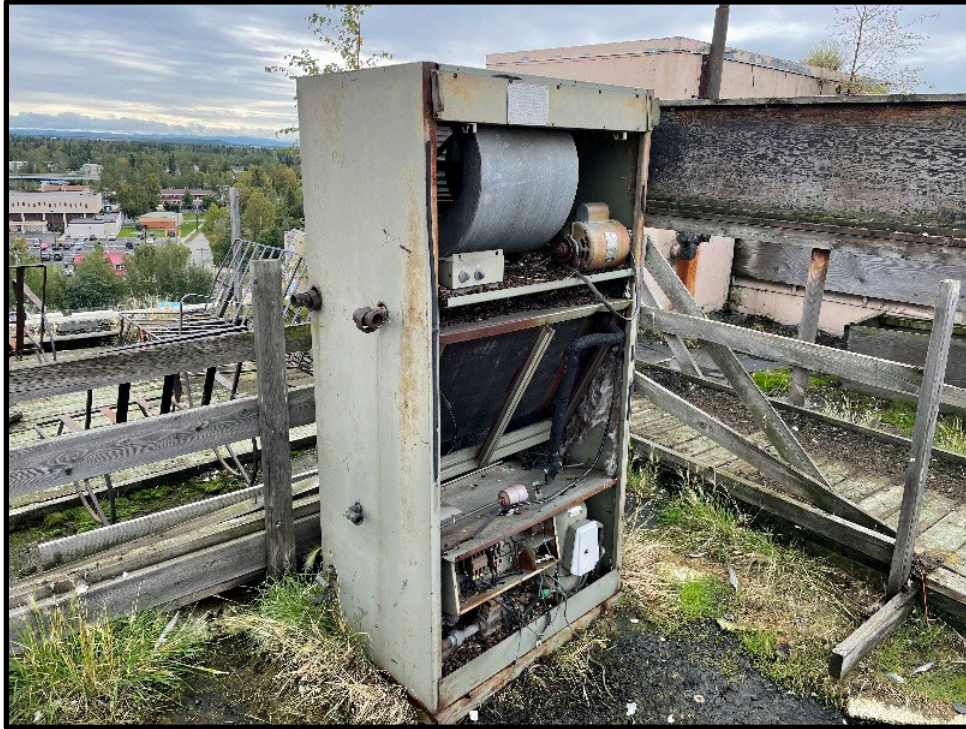
**Photo 23:** Air handling unit (R-24) - Roof

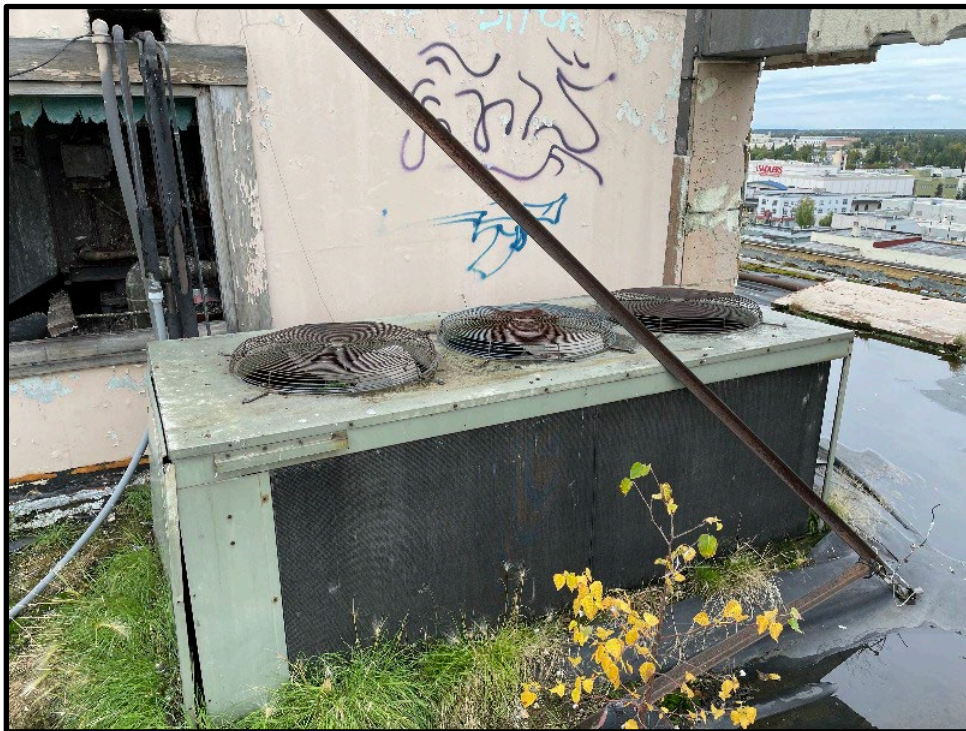
**Photo 24:** Air handling condenser (R-25) - Roof
