**SUSTAINABLE ENVIRONMENT, ENERGY,
HEALTH & SAFETY PROFESSIONAL SERVICES**

August 15, 2023

**RE: Limited Hazardous Materials Testing – HUD Compliant Lead Survey
Child Care Renovations at City Hall - Fairbanks, Alaska**

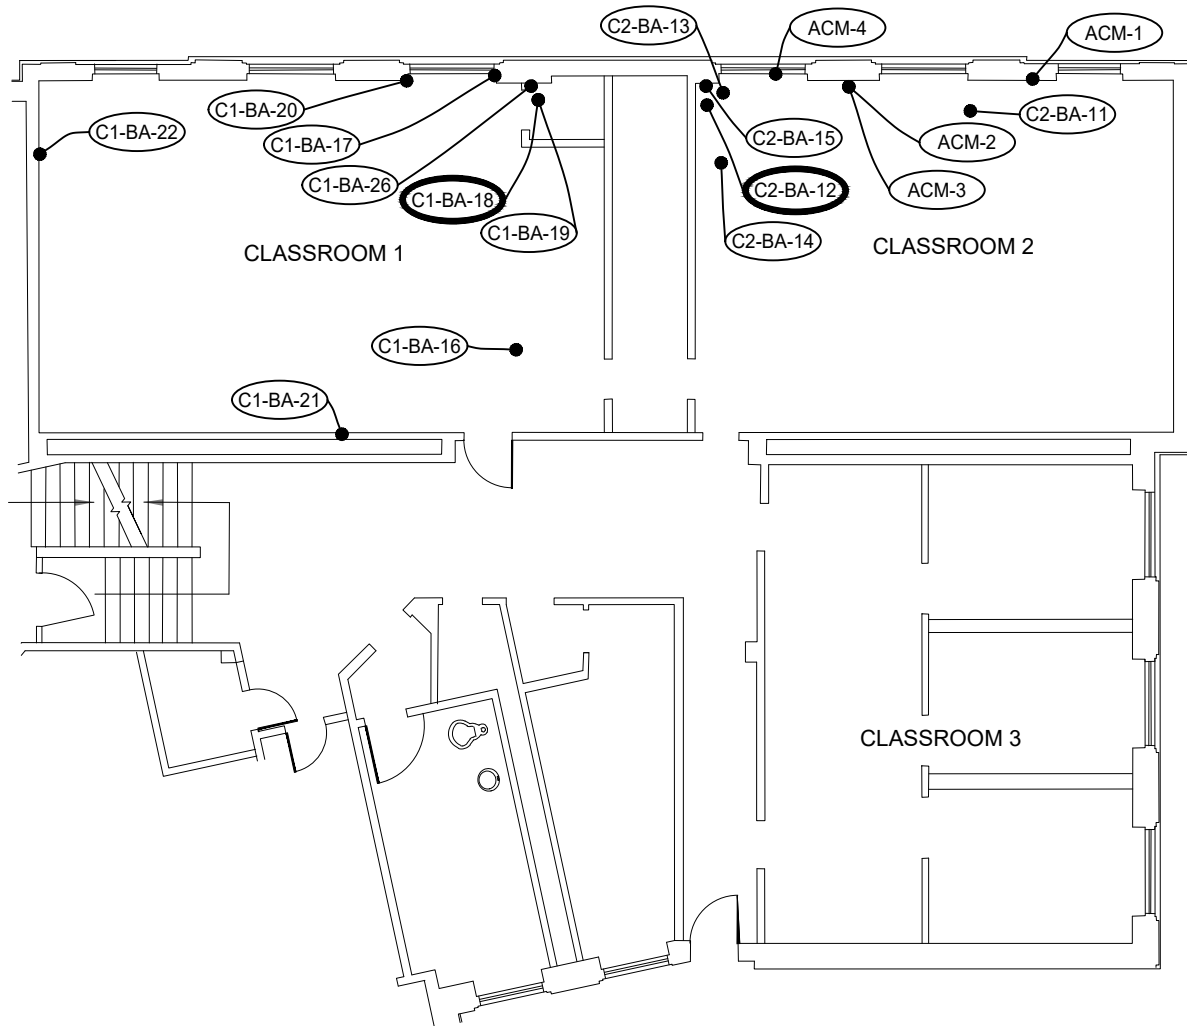
Classroom 1 & 2
 Asbestos Sample Locations & Results
 Child Care Renovation - Hazardous Materials Assessment
 City Hall, Fairbanks, Alaska

The laboratory reported one sample layer taken from the ceiling tiles in Classroom 2 as asbestos containing glazing. The area was reinspected for the suspect ACM and several additional samples were taken from the area to verify the presence of ACM. Based on the additional lab analysis, sample C2-BA-10 has been removed from the data tables and laboratory report because it was not reproducible.

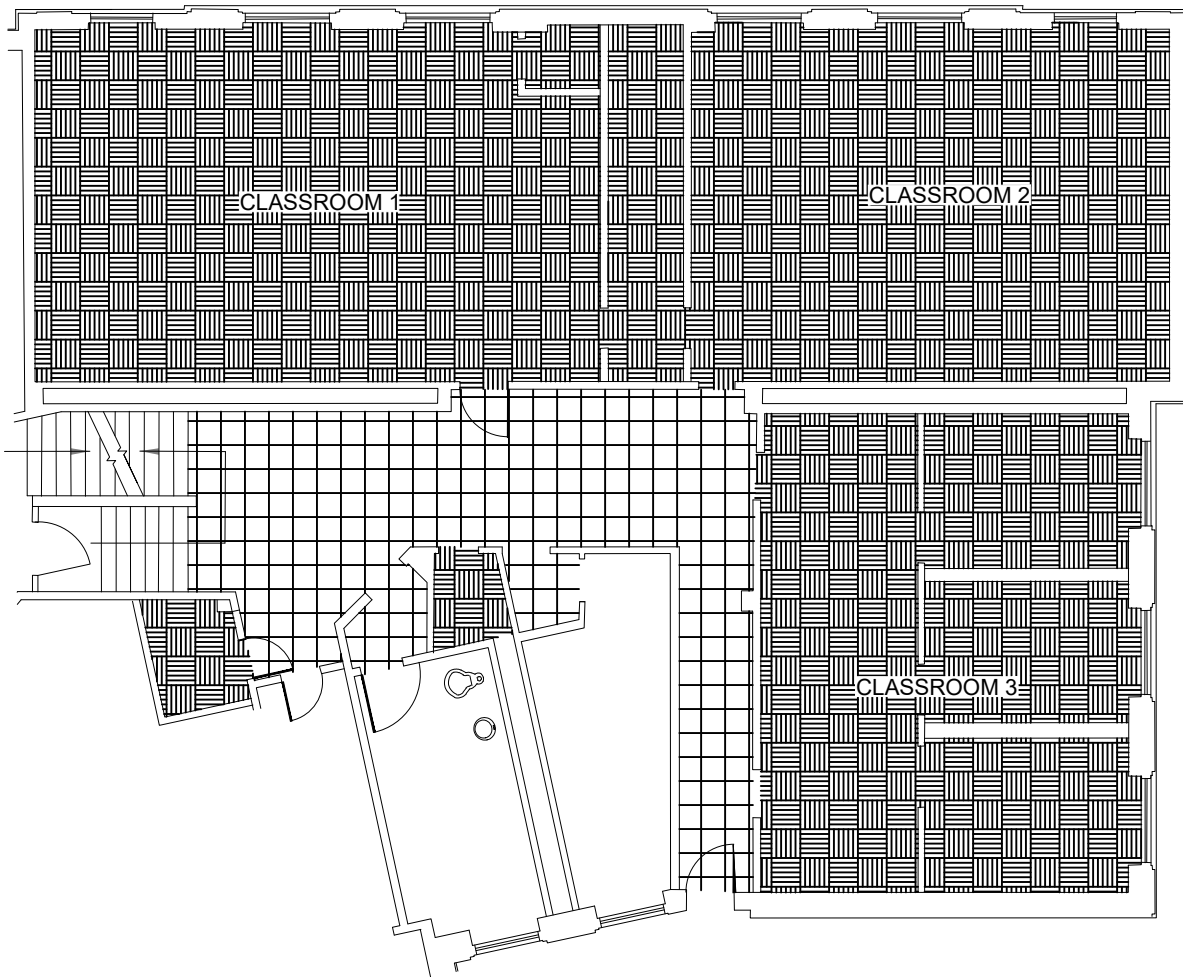
Classroom 1, 2, 3, & Other Areas
Asbestos Containing Material Locations
Child Care Renovation - Hazardous Materials Assessment
City Hall, Fairbanks, Alaska

- Friable (RACM)
 - TSI on bathroom heating pipes 48 Linear feet
- Non-Friable (Category I)
 - Flooring tiles Approximately 2500 sq ft
 - Black Mastic Approximately 2500 sq ft
- Non-Friable (Category II)
 - None Detected

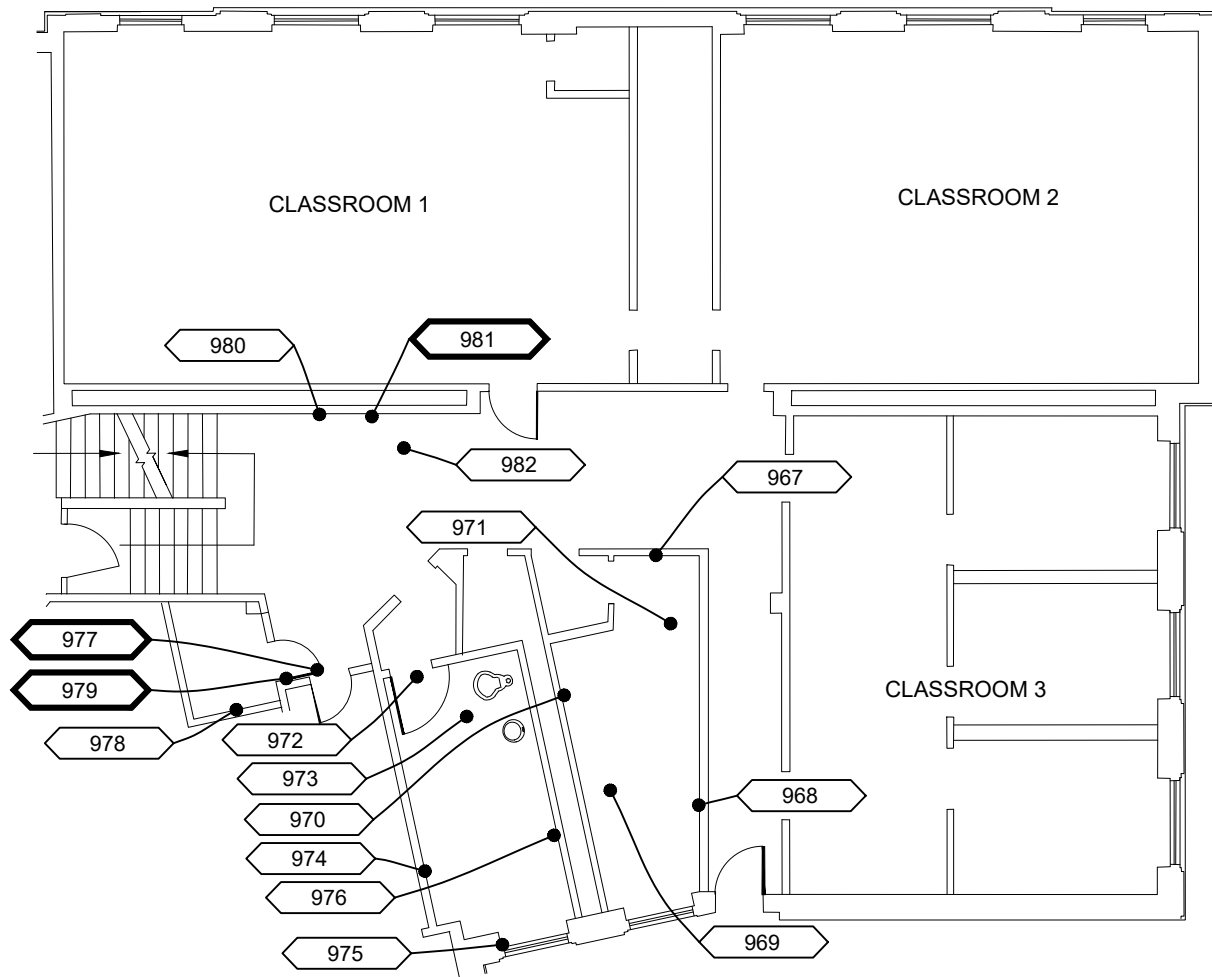
Other Areas
 Lead Sample Locations & Results
 Child Care Renovation - Hazardous Materials Assessment
 City Hall, Fairbanks, Alaska

Three lead results were above the HUD threshold of 1 mg/cm², with a high of 2.1 mg/cm² indicating lead paint is present in this wing of the building. A light green primer appeared to be the lead containing paint. This is visible in some locations and has been painted over with other colors in other locations. The green primer was found primarily in the hallway and not in the classrooms.

City Hall was built before 1978 and will require a HUD compliant lead survey prior to the facility being used as a childcare facility. The HUD Compliant assessment will look for lead-based paint in areas potentially disturbed by the proposed renovations. The assessment must be conducted by an EPA certified Lead Inspector and will follow Chapter 4 of the HUD Guidelines, 40 CFR Part 745 Subpart E, and 29 CFR 1926-6. The report for the HUD compliant survey will be separate from this report.

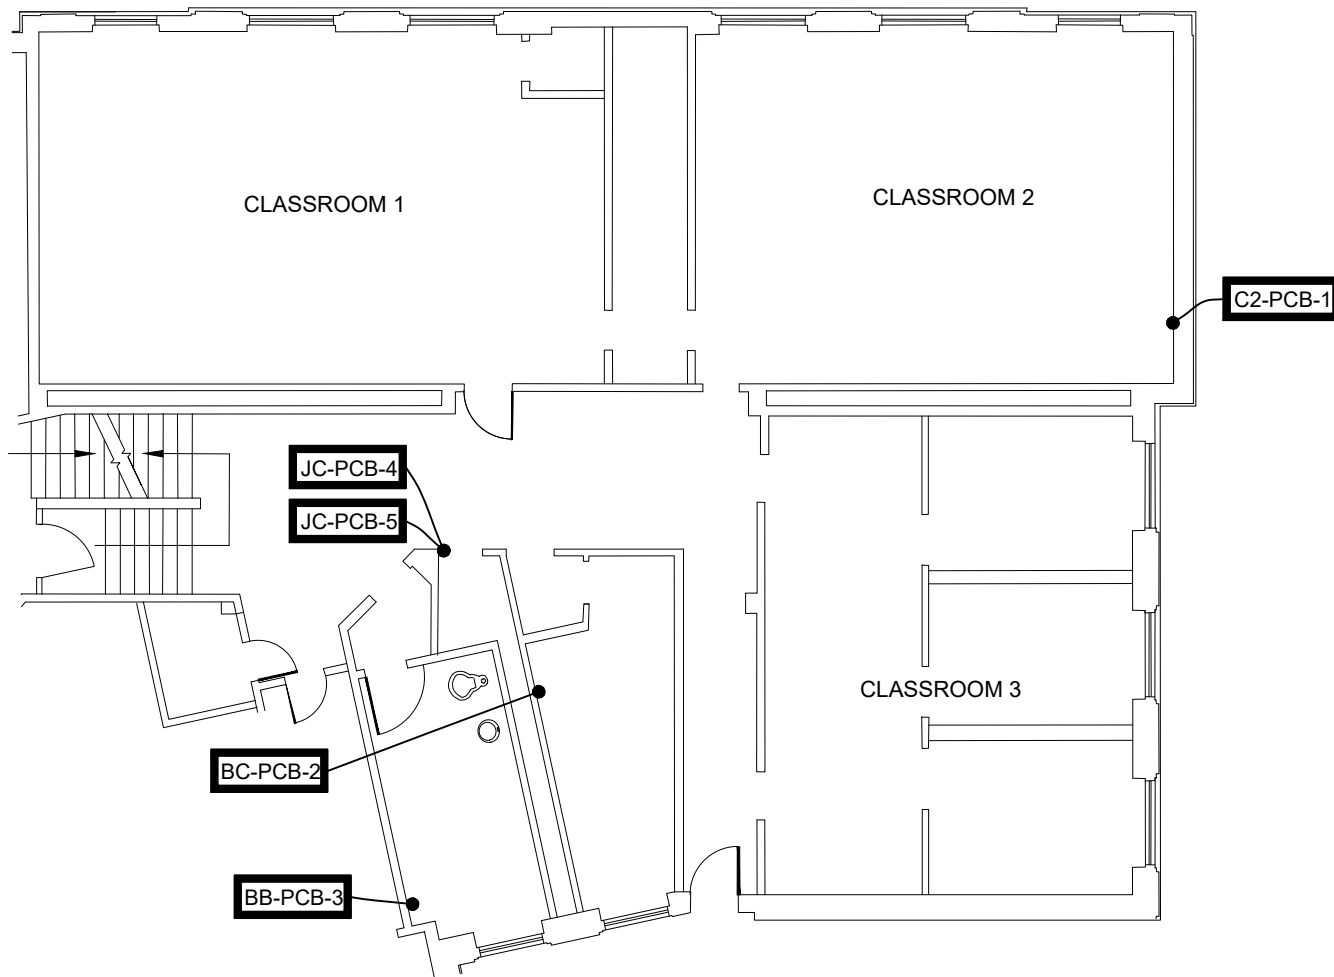
Class 2 & Other Areas
PCB Sample Locations & Results
Child Care Renovation - Hazardous Materials Assessment
City Hall, Fairbanks, Alaska

- C2-PCB-1 – white with yellow layers paint on stucco wall
 - Aroclor-1254 5.2 mg/kg
 - Aroclor-1262 0.85 mg/kg
 - Total Aroclor count 6.05 mg/kg
- BC-PCB-2 – tan/ green/ blue on wood bathroom stalls
 - Aroclor-1254 3.3 mg/kg
 - Aroclor-1260 0.40 mg/kg
 - Total Aroclor count 3.7 mg/kg
- BB-PCB-3 – white paint on wood bathroom stalls
 - Aroclor-1254 2.1 mg/kg
 - Aroclor-1262 0.33 mg/kg
 - Total Aroclor count 2.43 mg/kg
- JC-PCB-4 – Orange over green paint janitors closet door
 - Aroclor-1254 2.1 mg/kg
 - Aroclor-1260 0.24 mg/kg
 - Total Aroclor count 2.34 mg/kg
- JC-PCB-5 – white paint on janitor closet door
 - Aroclor-1254 5.6 mg/kg
 - Aroclor-1260 1.2 mg/kg
 - Total Aroclor count 6.8 mg/kg

These lab results indicate that levels of PCBs above 1 mg/kg are present on the bathroom stalls, doors, and walls in the proposed renovation area. Within Alaska PCB concentration between 1 ppm and 50 ppm are treated as “polluted soil”. Per regulation, Alaska landfills currently will not accept any PCB material > 1 ppm. While the official regulations do allow disposal of materials with a PCB concentration <1 ppm, most disposal facilities in Alaska have reportedly refused to accept materials containing any detectable PCBs. The contractor is required to verify with the chosen disposal landfill operator that the landfill permit accepts PCB waste below 1 ppm prior to disposal of the waste stream to avoid any potential regulatory concerns. Segregation of unpainted wastes is recommended to minimize the quantity of material that requires disposal outside the State of Alaska.

PCB related demolition activities pose a health risk to workers. EPA warns metals coated with paints containing PCBs should not be cut with flame, as the temperatures produced by the cutting may produce highly toxic polychlorinated dibenzofurans (PCDFs) that can be up to 100 times more toxic than certain PCBs. Other activities that may also be considered high risk include welding, sandblasting, burning, grinding, and sanding, which may elevate the temperature of the paint to unsafe levels or cause significant dusting. Planned demolition activities must be done in accordance with a project specific plan that minimizes potential worker exposure and provides the public with confidence that PCBs are not being released from the demolition activities.

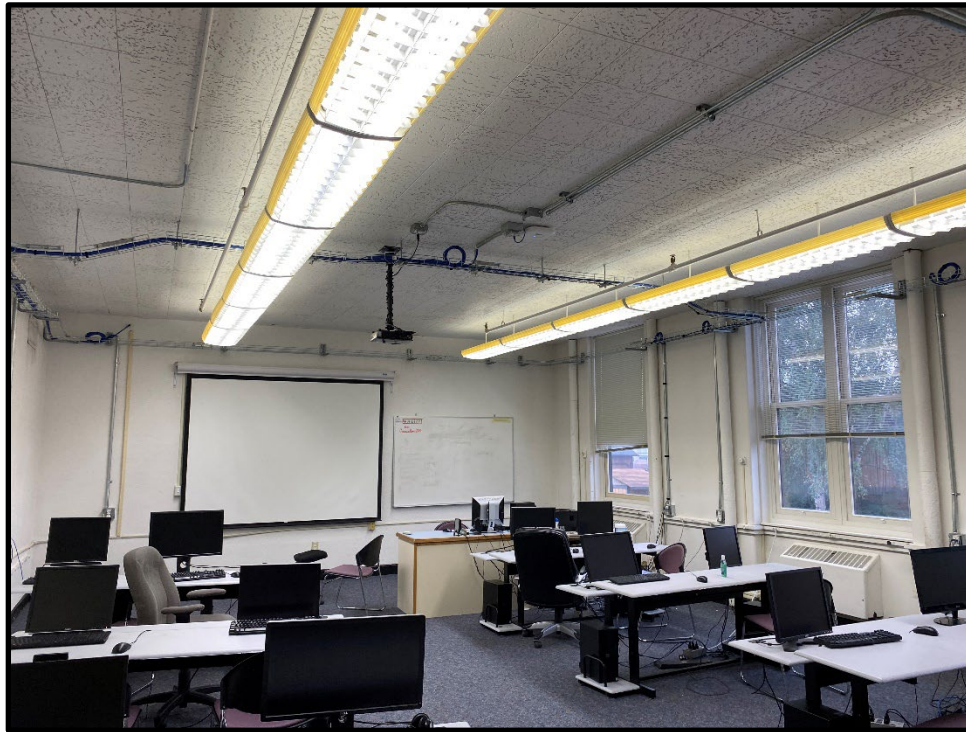
Non-friable ACM is divided into Category I and Category II materials. Category 1 asbestos present includes flooring tiles and mastic under carpet throughout the classrooms. If removed non-friable Category I asbestos will require demolition/abatement by certified asbestos workers using Class II OSHA methods and disposal as ACM debris. Any abatement or demolition activities should be completed under a project-specific work plan developed by the contractor to meet state and federal requirements.

Photo 1: Classroom 1 has two layers of carpet over ACM flooring tiles

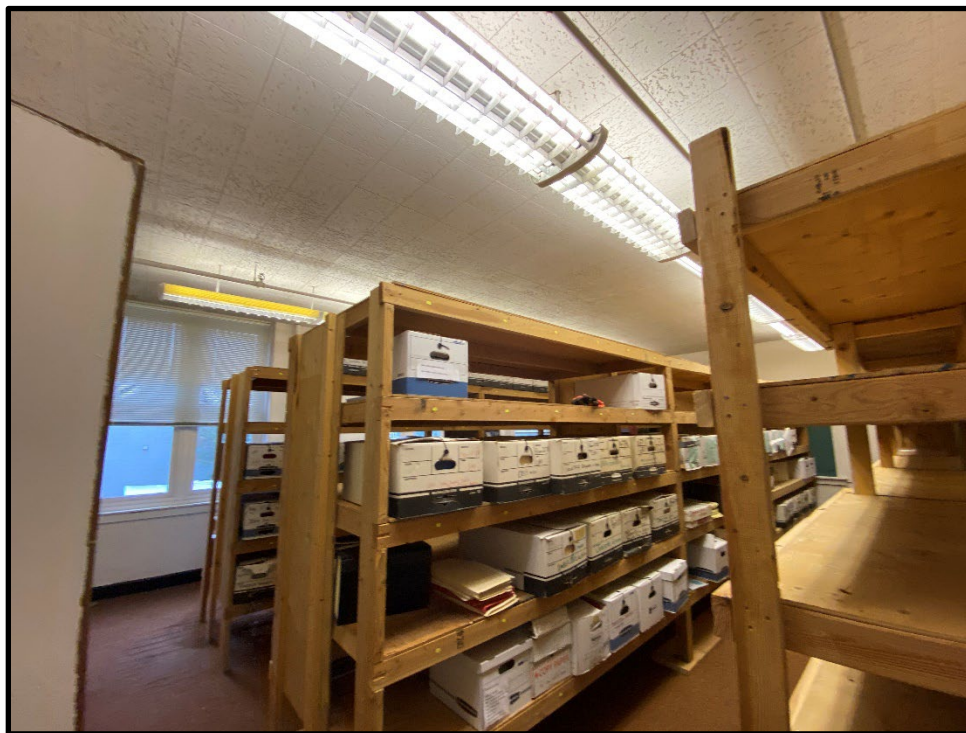
Photo 2: Classroom 2 has one layer of carpet over ACM flooring tiles

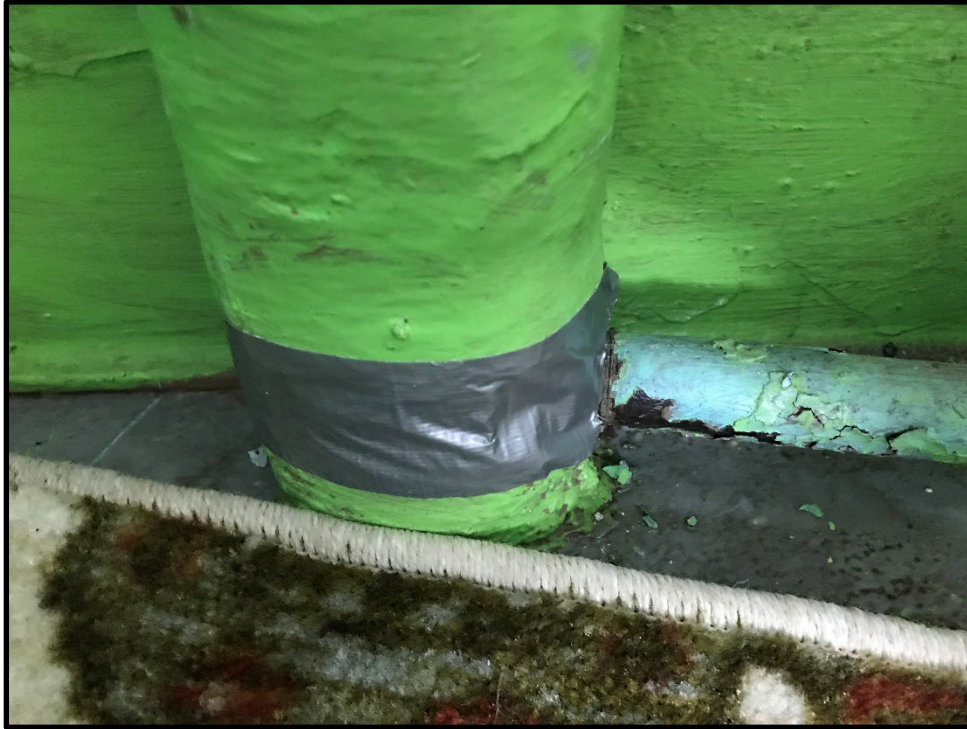
Unlabeled thermal systems insulation (TSI) was found in both Restroom 1 and 2 and was positive for asbestos. TSI covers radiator supply and return piping from ceiling to near ground level. TSI with greater than 1% asbestos is considered a Regulated Asbestos-Containing Material (RACM). RACM is any asbestos-containing material that when dry, can be crumbled or reduced to powder by hand pressure. If it can be crumbled it is called “friable”. Friable ACM requires abatement by certified asbestos abatement workers using OSHA Class I methods. Friable asbestos that is damaged or severely damaged, or found as debris, presents a high potential for possible exposures above the Occupational Safety and Health Administration (OSHA) permissible exposure limit (PEL) of 0.1 fibers per cubic centimeter (f/cm³).

Photo 3: Asbestos containing TSI in restroom 2 on heat piping

- Asbestos containing materials were identified in this area and an asbestos work plan is necessary for renovation activities.
 - Friable ACM (RACM) requires abatement by certified asbestos abatement workers using OSHA Class I methods

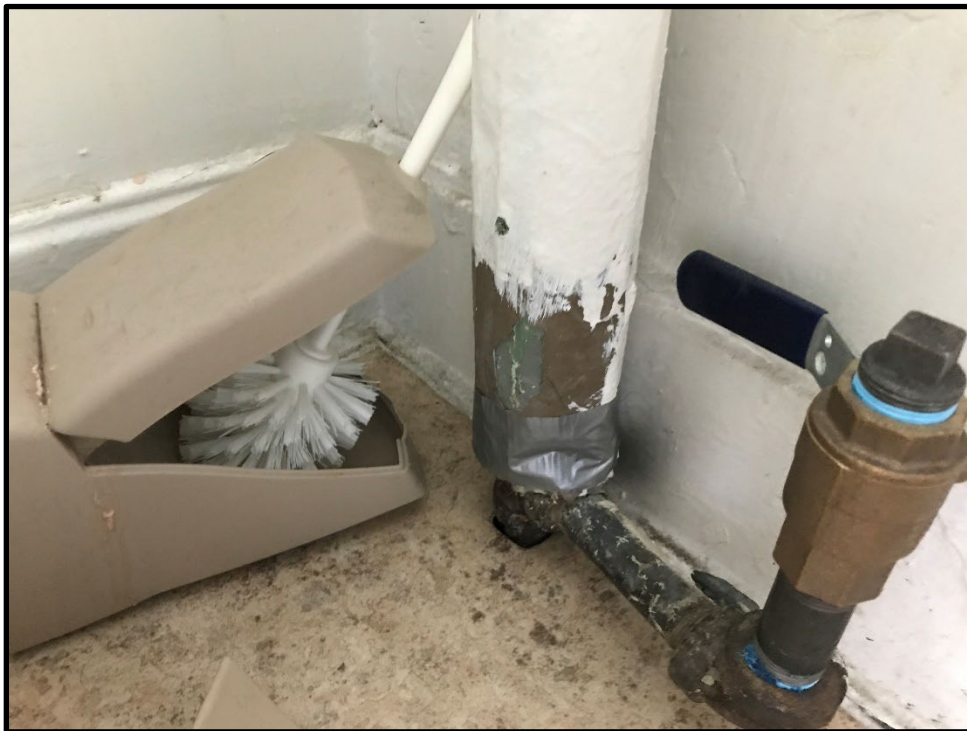
Photo 4: Asbestos containing TSI in restroom 1 on heat piping

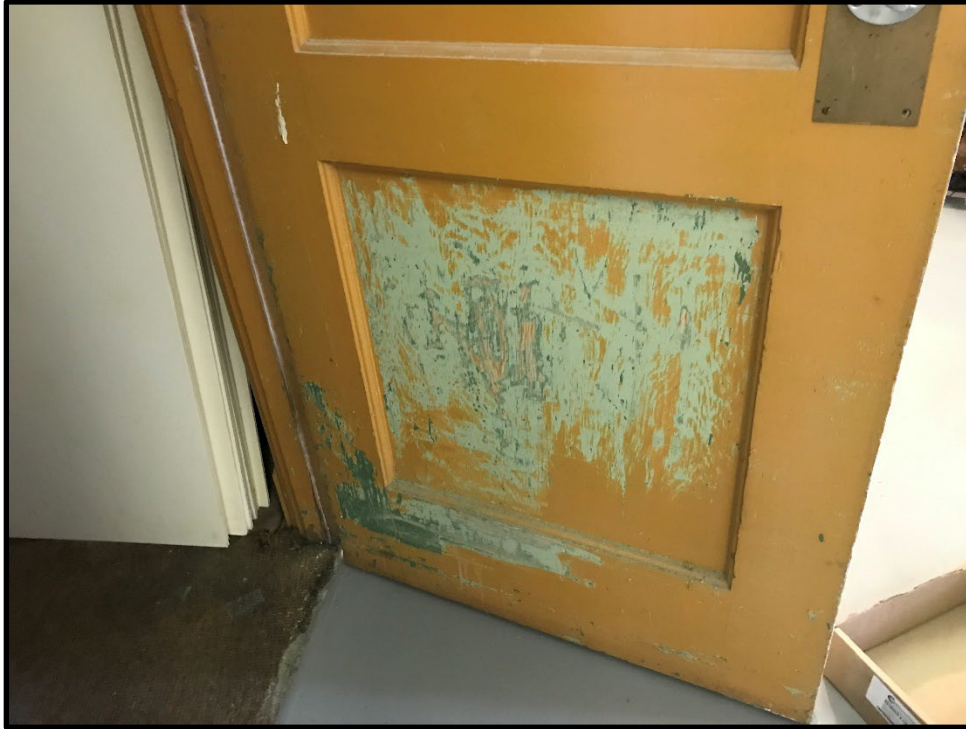
Photo 5: PCB containing paint was found on the interior and exterior of the janitor closet door.
Assume all doors are PCB containing.

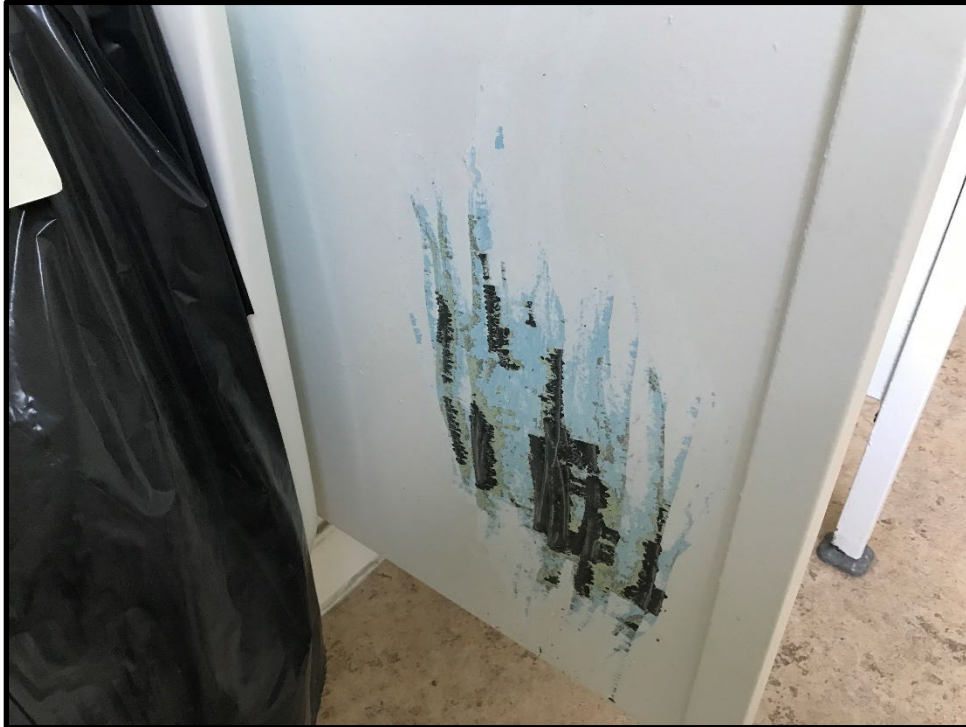
Photo 6: PCB containing paint found on the divider stalls in restroom 2. Assume at restroom dividers are PCB containing.
