## **Appendix C Hazardous Materials Figures and Data Polaris Tower – Fairbanks, Alaska**

**NORTECH** has compiled the existing hazardous materials data for the Polaris Tower for use as part of the demolition planning of this structure. This information is expected to be provided to prospective bidders as an appendix to Specification Section 801 that describes the requirements for abatement and/or demolition of these materials.

The potentially hazardous materials listed below are known or suspected to be present in the Polaris Tower. These have been identified through inspection and sampling and the sample locations and results are included in the attachments to this document.

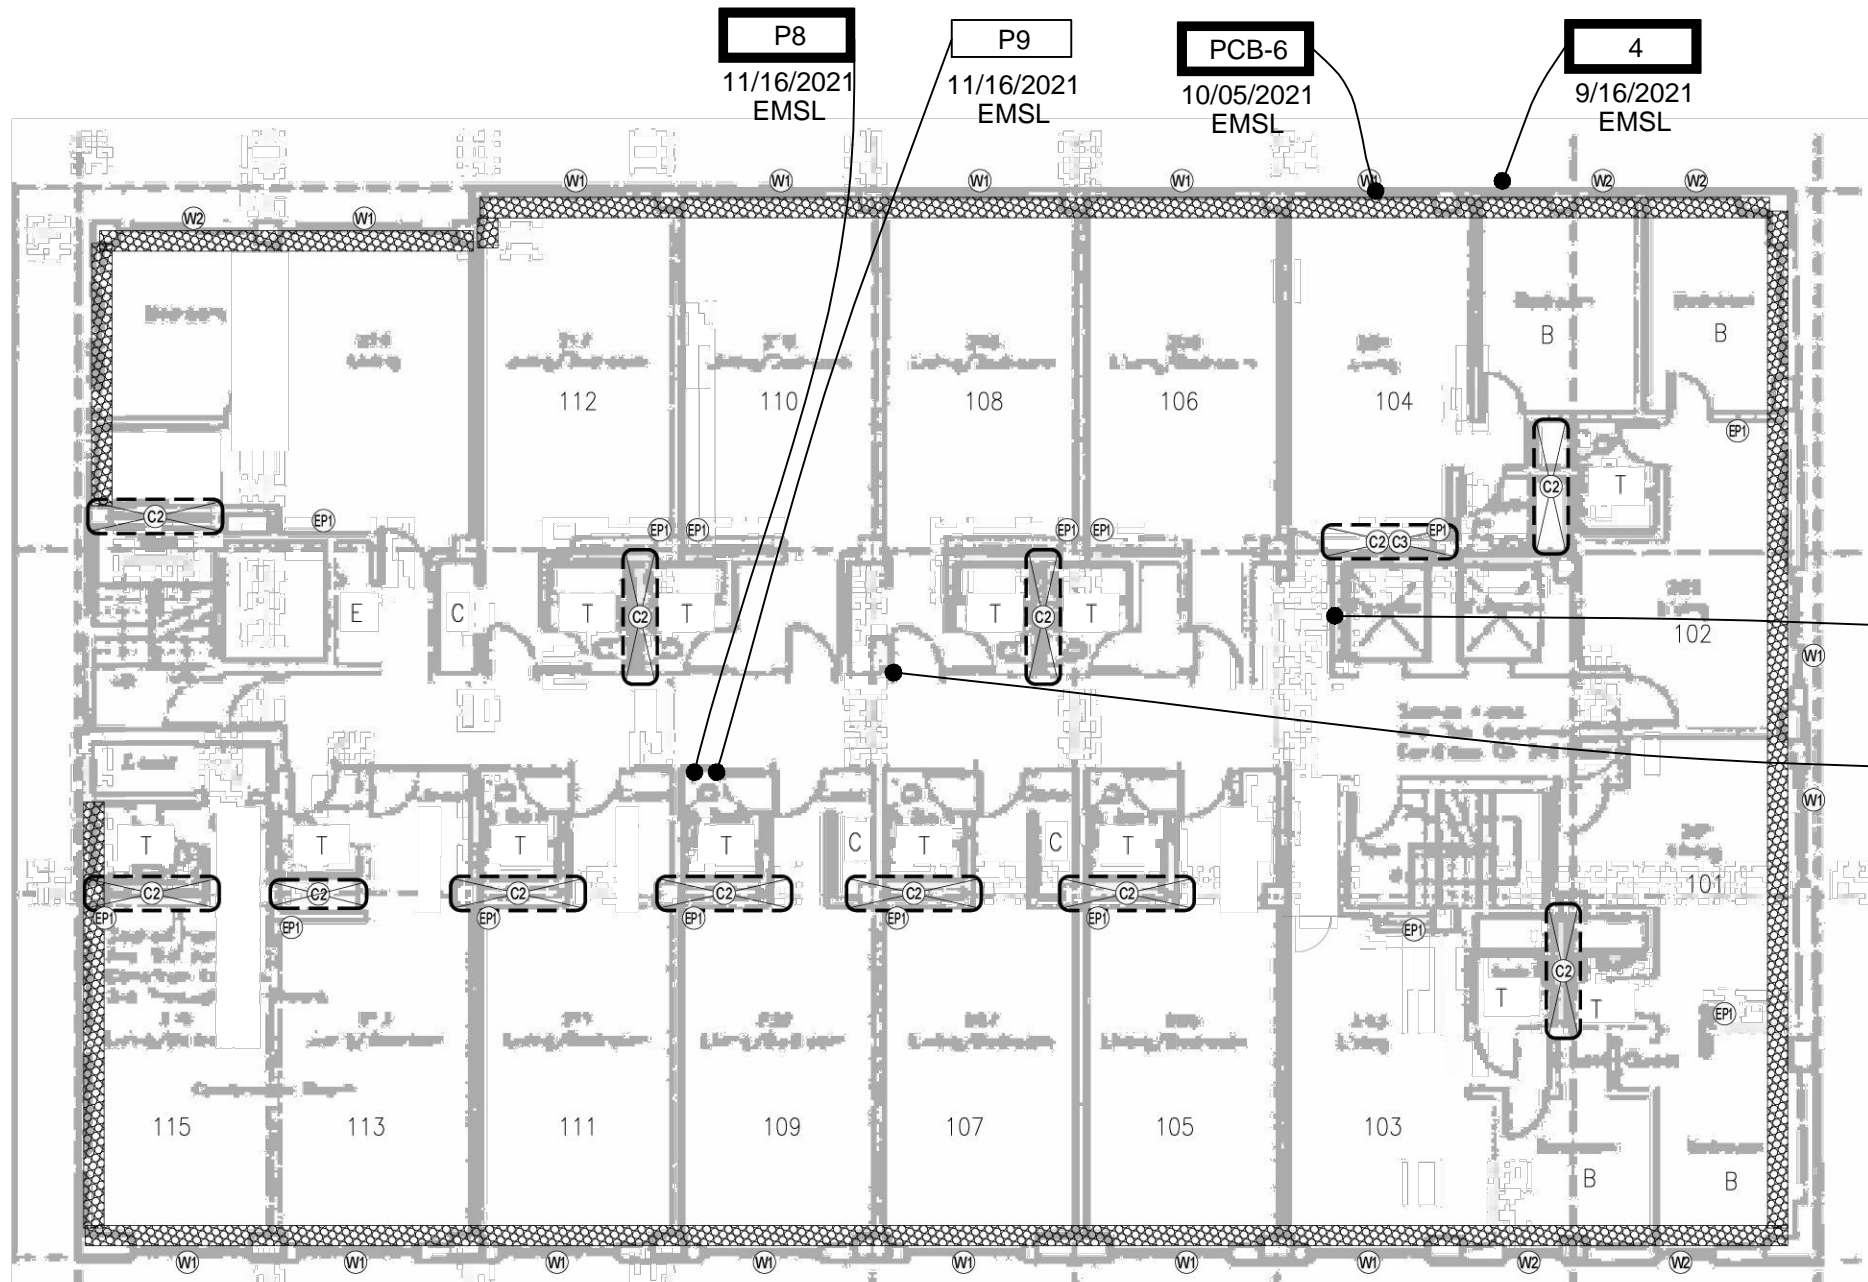
FIGURE  
4

Main Floor Lead Sample Locations & Results  
 Polaris Hazardous Materials Investigation  
 Fairbanks, Alaska
