**SUSTAINABLE ENVIRONMENT, ENERGY,
HEALTH & SAFETY PROFESSIONAL SERVICES**

August 15, 2023

**RE: Limited Hazardous Materials Testing – HUD Compliant Lead Survey
Child Care Renovations at City Hall - Fairbanks, Alaska**

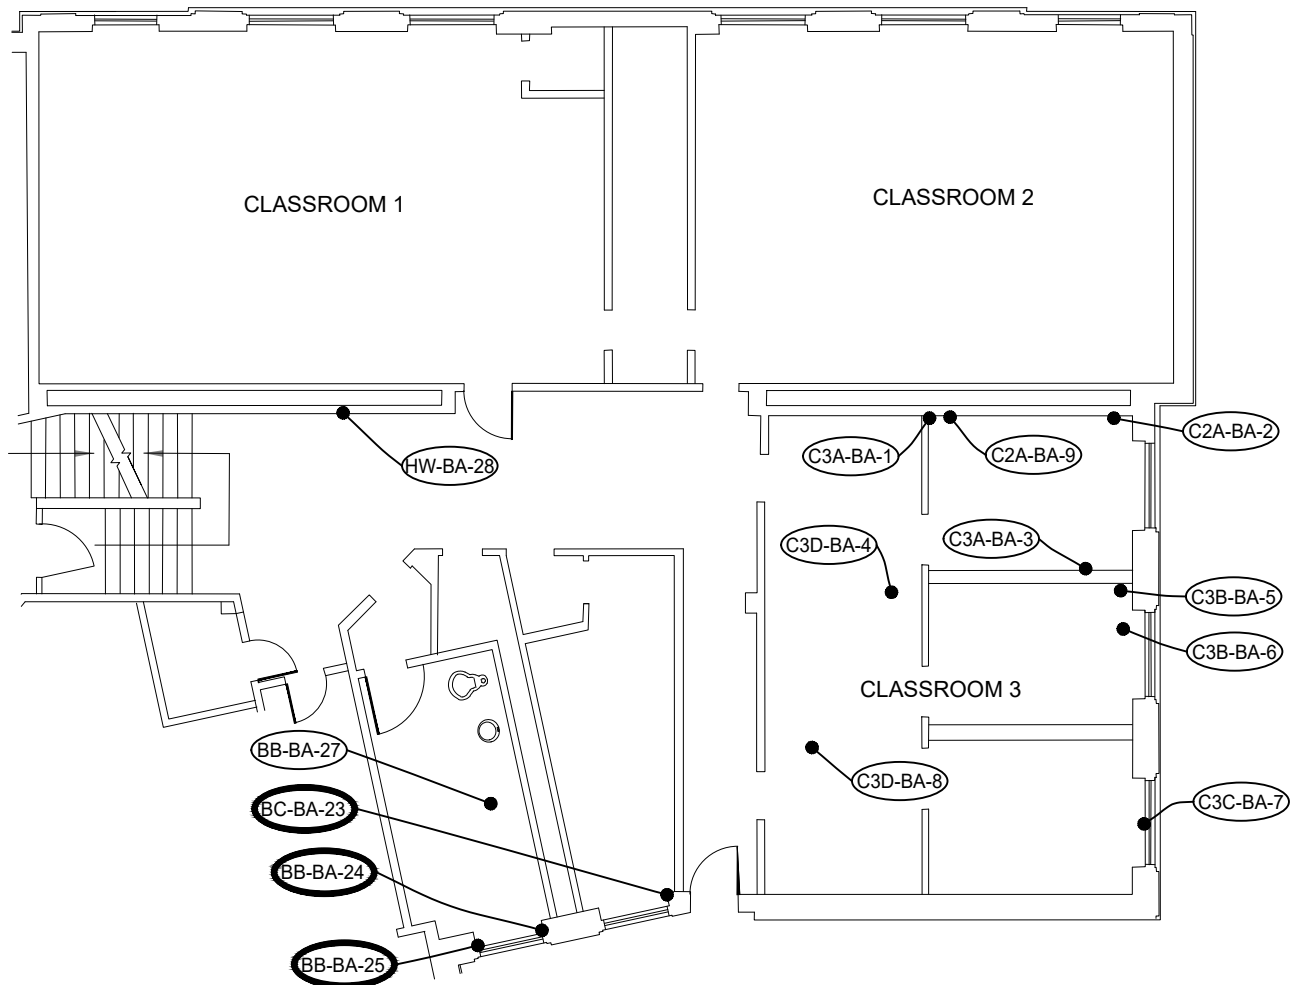
Asbestos Sample Results		
Asbestos Sample Results (Method EPA 600/R-93/116)		
Sample ID	Description	Result
BC-BA-23	white/green TSI	30% Amosite, 8% Chrysotile
BB-BA-24	brown/gray/tan TSI	50% Chrysotile
BB-BA-25	white TSI	30% Amosite, 10% Chrysotile
BB-BA-27	beige cove base & yellow mastic	ND
HW-BA-28	white texture	ND

Asbestos Sample Results		
Asbestos Sample Results (Method EPA 600/R-93/116)		
Sample ID	Description	Result
C3A-BA-1	brown cove base	ND
C3A-BA-2	gray/white ceiling tile - Type 1	ND
C3A-BA-3	gray/white ceiling tile - Type 2	ND
C3D-BA-4	gray/white ceiling tile - Type 3	ND
C3B-BA-5	yellow pipe insulation & mastics	ND
C3B-BA-6	gray floor tile	5.5% Chrysotile
C3B-BA-6	black mastic	2.3% Amosite, 3.4% Chrysotile
C3C-BA-7	brown carpet & yellow mastic	ND
C3D-BA-8	gray floor tile	5.8% Chrysotile
C3D-BA-8	black mastic	<0.25% Chrysotile
C3A-BA-9	white/black mastic	ND

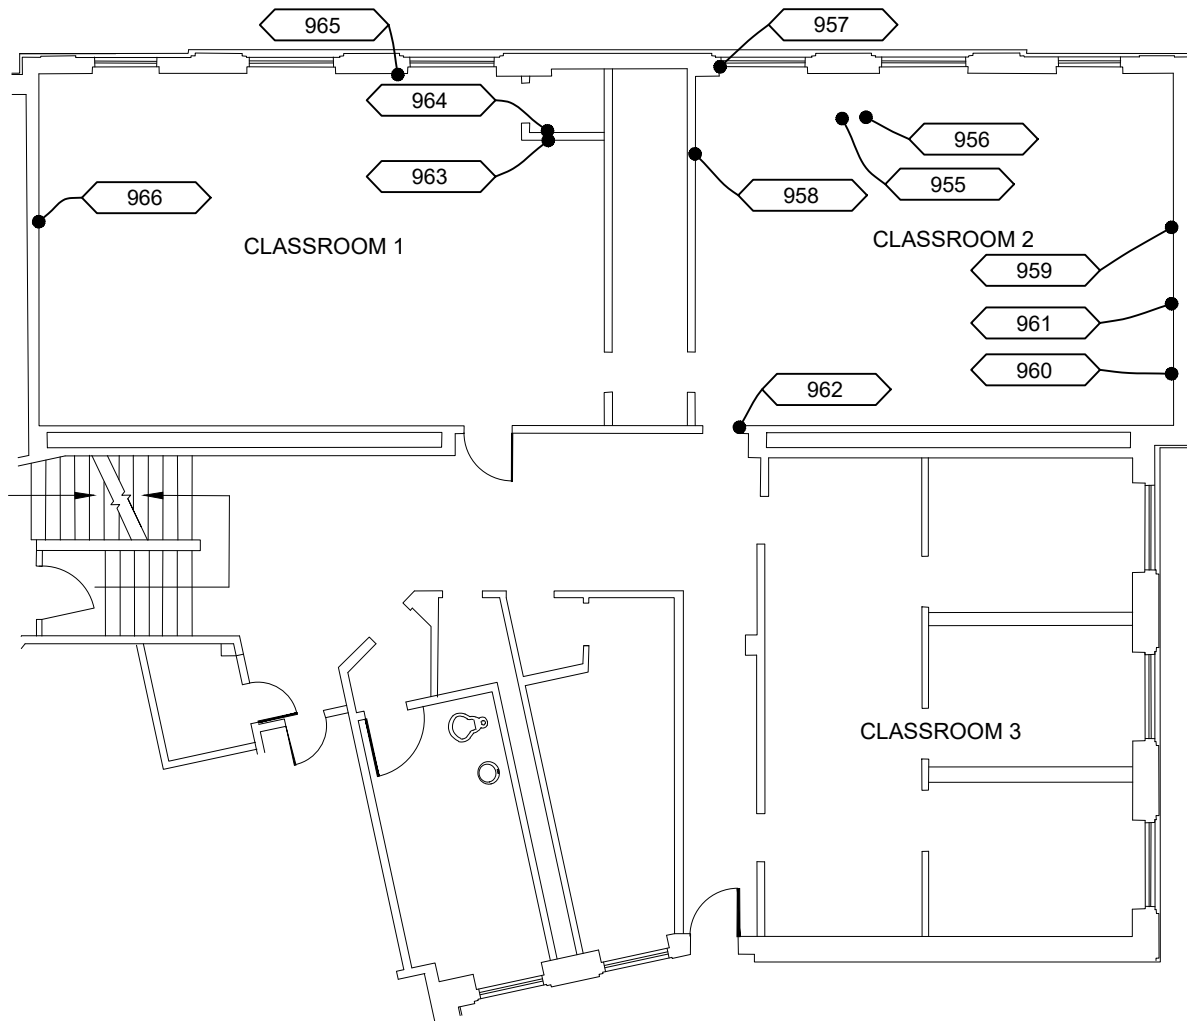
Classroom 1 & 2
 Lead Sample Locations & Results
 Child Care Renovation - Hazardous Materials Assessment
 City Hall, Fairbanks, Alaska

Lead Sample Results				
Number	Color	Surface	Substrate	Result (mg/cm ²)
963	black	wall	gwb	0.00
964	pink	wall	stucco	0.18
965	white	wall	stucco	0.00
966	white	wall	stucco	0.00

Lead Sample Results				
Number	Color	Surface	Substrate	Result (mg/cm ²)
955	white	ceiling tile	MDF	0.00
956	gray	floor	concrete	0.6
957	white	wall	stucco	0.5
958	white	wall	stucco	0.01
959	green	chalkboard	slate	0.06
960	gray	trim	metal	0.3
961	white	wall	particle board	0.8
962	white over green	door	wood	0.7

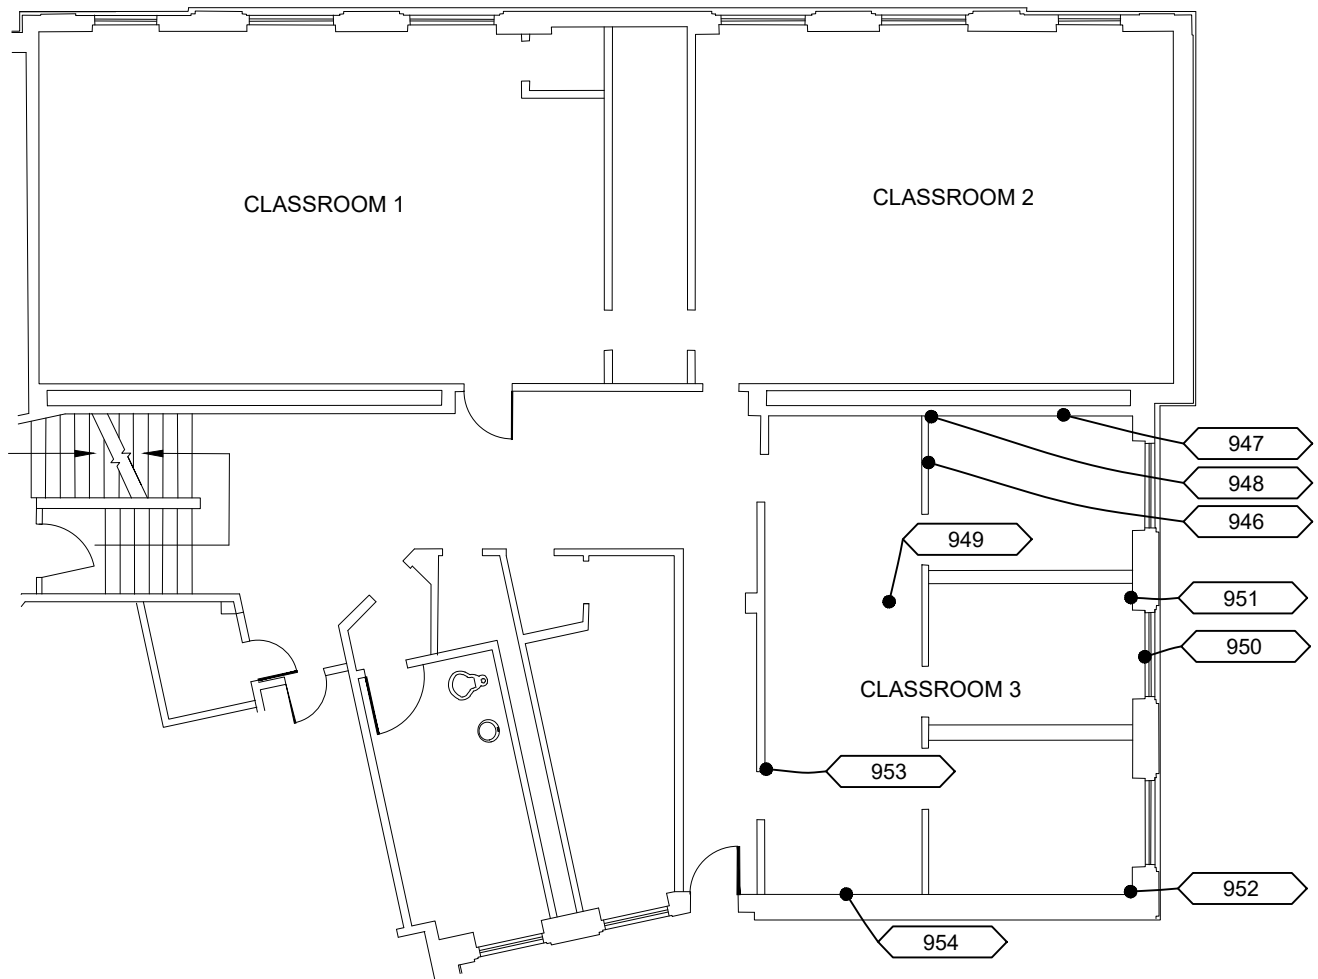
Classroom 3
 Lead Sample Locations & Results
 Child Care Renovation - Hazardous Materials Assessment
 City Hall, Fairbanks, Alaska

Lead Sample Results				
Number	Color	Surface	Substrate	Result (mg/cm ²)
946	stain	panel	wood	0.00
947	tan	wall	stucco	0.00
948	yellow	trim	wood	0.3
949	beige	floor	concrete	0.08
950	white	heat register	metal	0.22
951	white	wall	stucco	0.29
952	light brown	wall	stucco	0.28
953	blue	wall	stucco	0.00
954	white	wall	particle board	0.01
